Pitting corrosion on 316L pipes in terephthalic acid (TA) dryer

Y. Gong, J. Cao, X.-H. Meng and Z.-G. Yang*

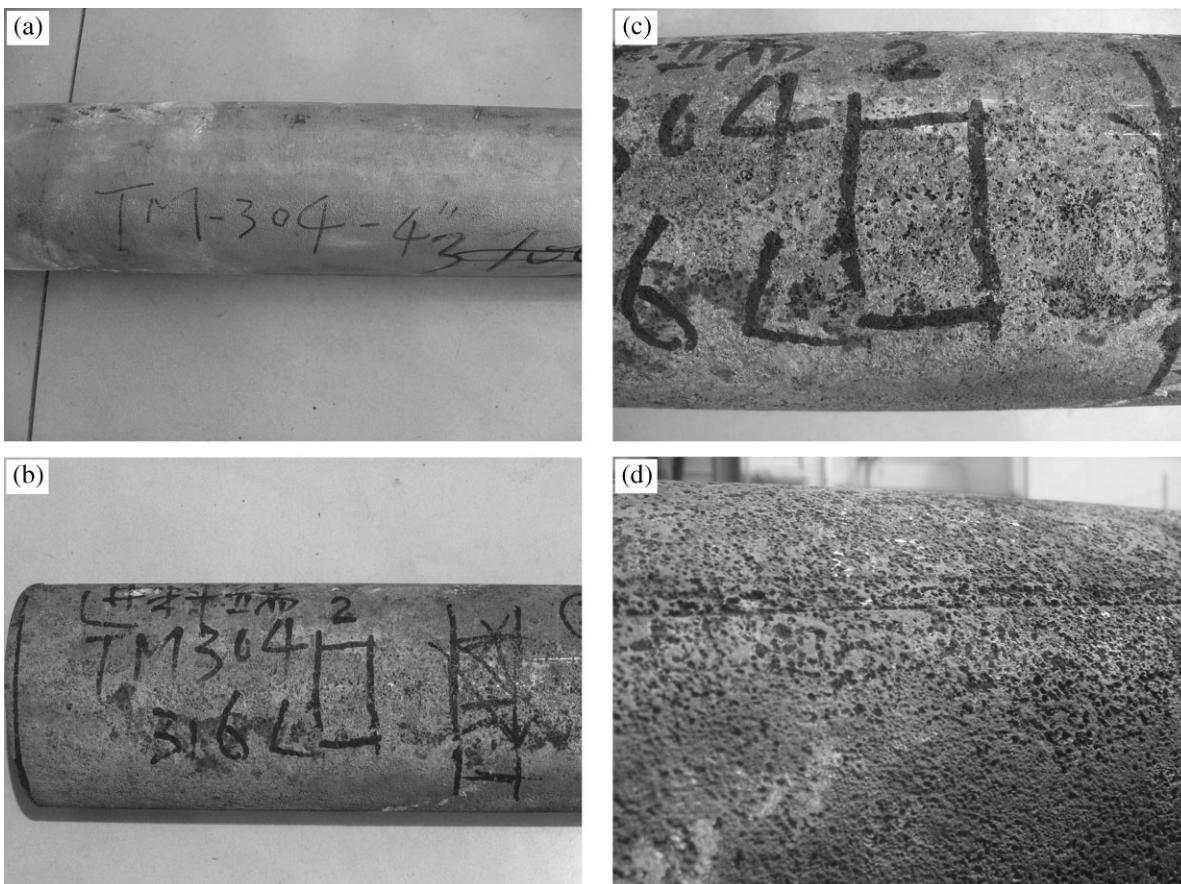
through the steam pipes to heat the wet TA cakes that are transported outside the pipes from the inlet region of the dryer. Moreover, carrier gas (nitrogen) is sent in the opposite direction of the transportation of the cakes, i.e. from the output region of the dryer to remove the vapors evaporated from the cakes. More concrete details of the operating conditions of TA dryer can be referred from Fig. 2. In this paper, pitting dominantly took place at the inlet region of the steam pipes. Compared with the surface of the pitting-free pipes (Fig. 3(a)), which was smooth and plane, the surface of the pitted pipes was covered with a relatively large area of pits [Fig. 3(b)]. As shown in Fig. 3(c) and (d), many corrosion pits were randomly distributed on the pipe surface, and the depth of some pits even reached 0.5 mm.

Figure 3. Macroscopic morphologies of pitted steam pipes surface; (a) pitting-free surface, (b) pitted surface, (c), (d) magnification of pitting morphology

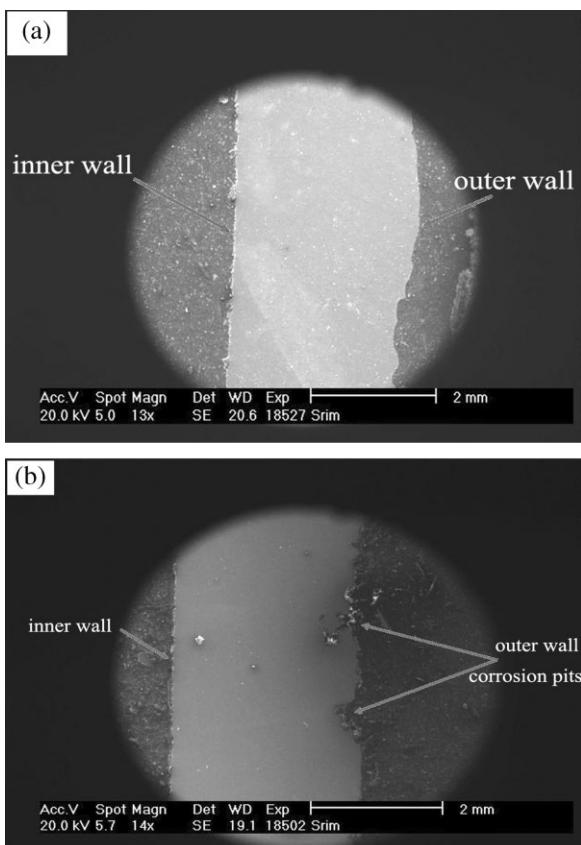
Samples were cut from the pitted region of the failure pipes and the cross-sections of these samples were observed under SEM. Explicit differences between the inner wall and the outer wall of the pitted pipes can be seen in Fig. 6(a) and (b). Compared

Figure 6. SEM of the cross-sections of pitted pipes

with the smooth inner wall, the outer wall was defected by some corrosion pits, whose depth had reached about 0.4 mm. As is well known, there are seven theoretical morphologies of pitting, namely, narrow and deep, elliptical, wide and shallow, subsurface, undercutting, horizontal, and vertical [8]. Schematic diagrams of the seven theoretical morphologies are displayed in Fig. 7. In this paper, it can be seen from Fig. 8 that six out of the seven theoretical pitting morphologies were obtained from the pitted pipes under SEM, which may provide a solid proof for the

Regarding the corrosion rate of 316L steel in the acetate acid containing halide ions, some experiments on the corrosion depth were carried out [37, 38]. Mattsson [39] defined the corrosion rate of qualified stainless steel to be not more than 0.1 mm·y⁻¹. Fig. 6(a) provides the evidence of thinning of the pitted pipes, for a thickness of 2.74 mm compared with its original value of 3.0 mm. Service conditions of the steam pipes may be attributed cause for such a serious thinning. As shown in Fig. 2, the steam pipes in the inlet region of TA dryer contact both the wet TA cakes and the carrier gas, which may lead to a two-phase (gas and liquid) FAC on the steam pipes' surface due to the high humidity of the wet TA cakes [40, 41]. FAC is a kind of corrosion process of chemical dissolution of metal that always leads to thinning of pipes. That the corrosion deposits produced by aggressive liquid on the surface will be removed layer by layer by high-flow-rate gas may account for the acceleration effect from FAC. In this case, the metastable pipes' surface with delaminated corrosion deposits within the pits (Fig. 9) was abraded by carrier gas and it eventually resulted in thinning of its wall thickness. Thus, the cause for the serious pitting corrosion taking place only at the inlet region rather than at other parts of the steam pipes can be explained. The relatively high temperature near 130 °C is also a critical factor inducing the acceleration effect. According to Hou Feng's [37] experiments, the corrosion rate of 316L steel under the environment stimulated from the actual service condition of TA dryer (26.2% TA, 0.96% Br⁻, 67.11% HAc (wt%) at 110 °C) reached even 1 mm·y⁻¹. Finally it can be concluded that the serious corrosion situation and a quite high corrosion rate on the inlet region of steam pipes resulted from the interaction between pitting, FAC, and high temperature.

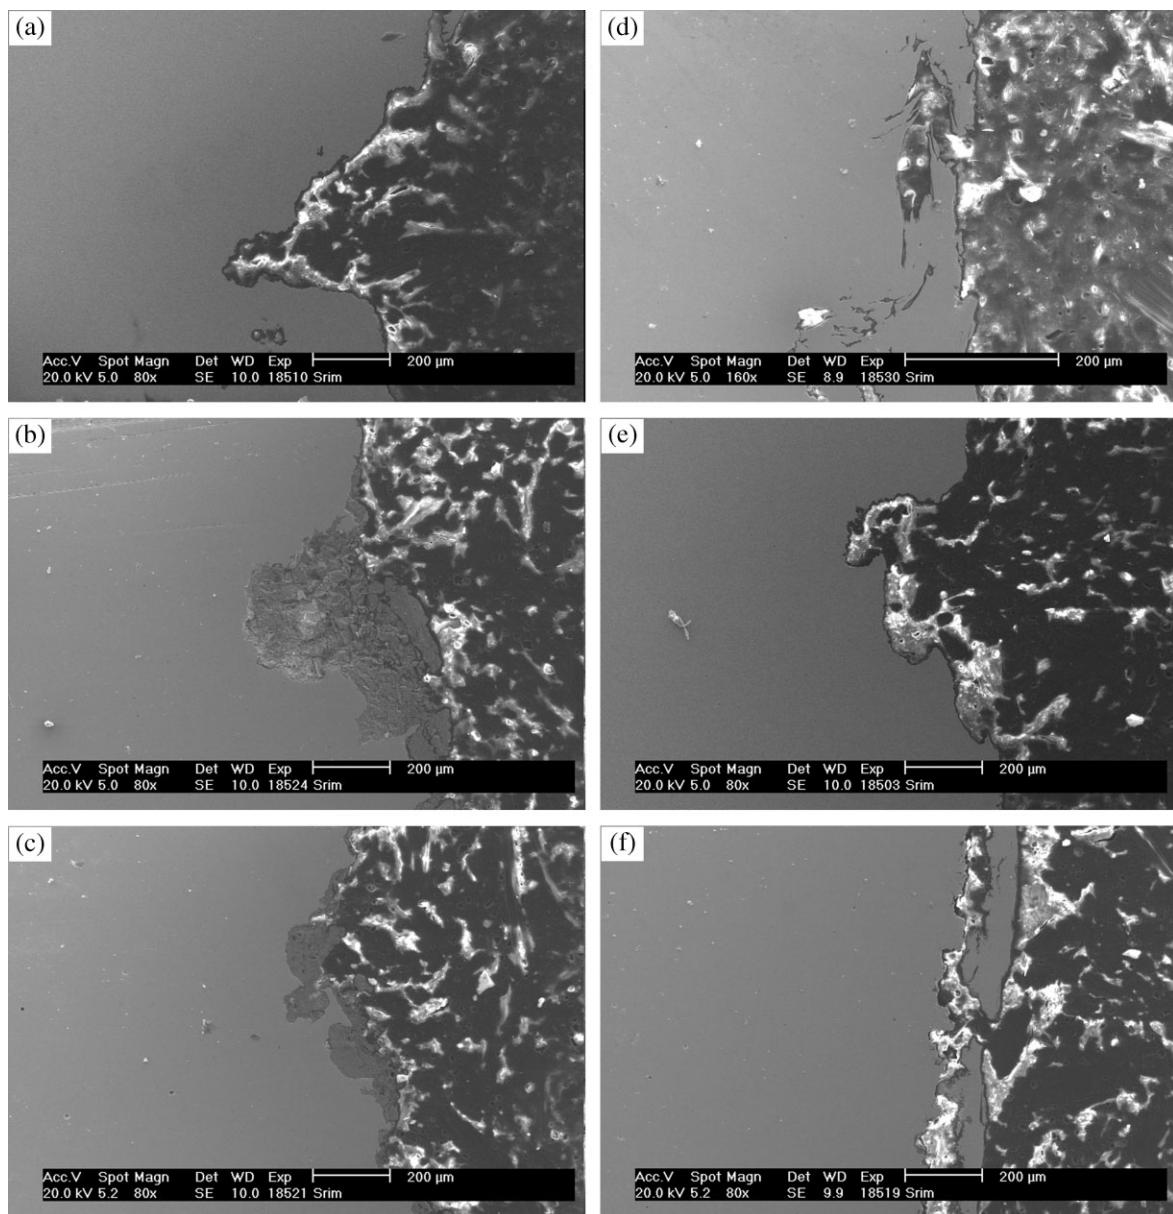
On taking a closer look at the corrosion deposits within the pit in Fig. 8(b), delamination can be found on the deposits, as seen in Fig. 9. It is well known that delamination may induce the deposits to be abraded layer by layer under the effect of flow (gas or liquid), which may result due to the acceleration of corrosion rate (detailed mechanisms will be discussed later). Furthermore, chemical compositions of the corrosion deposits were detected by energy dispersive spectroscopy (EDS). The four analysis sites are displayed in Fig. 9 as well, and the chemical compositions are listed in Fig. 10 and Table 2. According to the results of the analysis, it is surprising that the contents of chlorine element were 7.17, 5.36, 8.21, and 2.60% (wt%), respectively at sites A, B, C, and D. Moreover, 1.90% of the content was bromine element at site C. Hence, the EDS results verified the hypothesis proposed above that the pitting corrosion was led by the presence of halide ions.

Figure 8. SEM of pitting morphologies; (a) narrow and deep, (b) elliptical, (c) wide and shallow, (d) subsurface, (e) undercutting, (f) horizontal

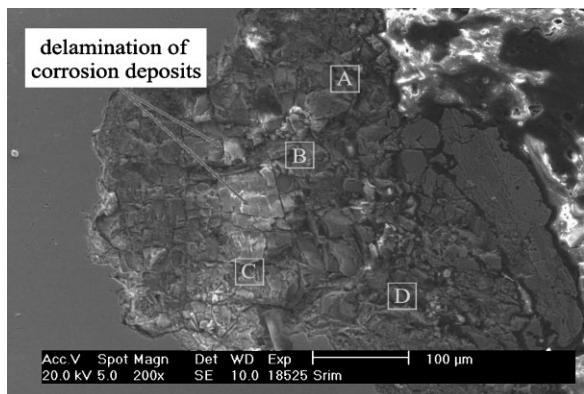
Figure 9. SEM of the delamination morphology of corrosion deposits within pit

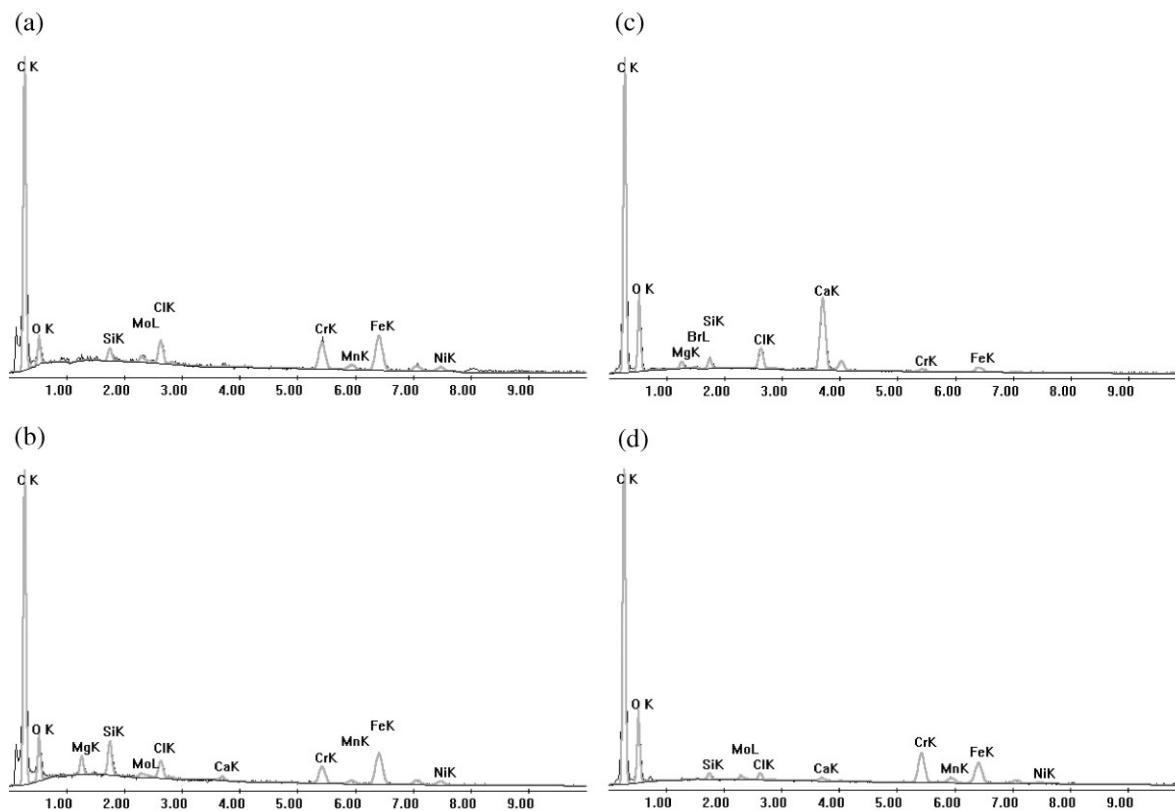
Figure 10. Chemical compositions of corrosion deposits; (a) site A, (b) site B, (c) site C, and (d) site D

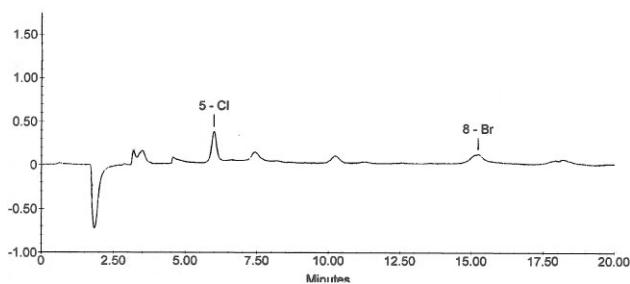
In order to further testify the EDS results, ion chromatography (IC) was also used to identify the chemical compositions of the corrosion deposits within the pits. When dissolved in deionized water, corrosion deposits released the chloride and bromide ions they contained. Fig. 11 shows that the concentrations of the chloride and the bromide ions are 10.5 and 1.0 ppm, respectively. Although the halide ions may not induce serious corrosion with such a low content at first, they will lead the pits to grow deep inwards in the matrix material when it is accumulated in the pits. Thus, the results of ion chromatography further confirmed the causes of pitting, the halide ions.

Figure 11. Ion chromatograph results of corrosion deposits within the pits
