Hydrogen Embrittlement on High-Speed Stainless Steel Belts Used for Tin Plating Chip Lead Frame

Abstract The 300 series stainless steels generally exhibit good corrosion resistance in common use. However, a premature fracture event caused by hydrogen embrittlement was encountered on 300 series stainless steels which was used as belt hanging chips in a tin plating process for the chip lead frame. The cause of the fracture was carefully studied. A metallurgical microscope and photoelectric direct reading spectrometer were used to examine the metallographic structures and chemical compositions of the matrix material. A scanning electron microscope and energy disperse spectroscopy were also applied to analyze the micro morphologies and micro-area composition of the fracture. Meanwhile, the chemistry and hydrogen content of the process media were inspected by ion chromatography and hydrogen analyzer. In addition, the finite element method was employed to simulate the effect on the belt from the service conditions. The analysis results revealed that the unqualified material selection, the aggressive media, and the inappropriate technological parameters were the main causes of the failur

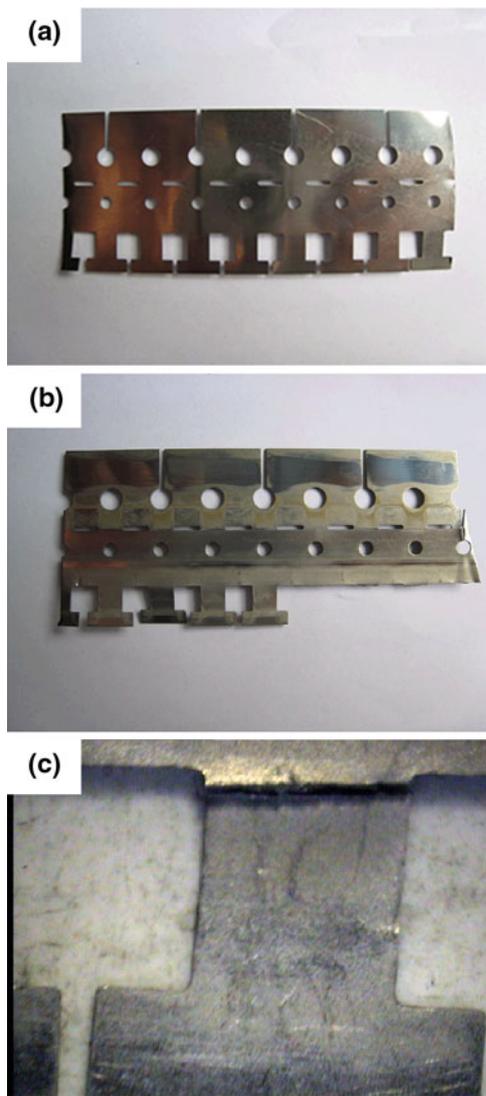
The different macro morphologies of the original and the failed stainless steel belts are shown in Fig. 2a and b,

respectively. Figure 2b indicates that the failed position is the bottom bracket of the belt. Moreover, the flat fracture is a sign of macroscopically brittle failure processes, seen in Fig. 2c.

Fig. 2 Macroscopic appearance of stainless steel belt: (a) original one, (b) fractured one, and (c) fracture

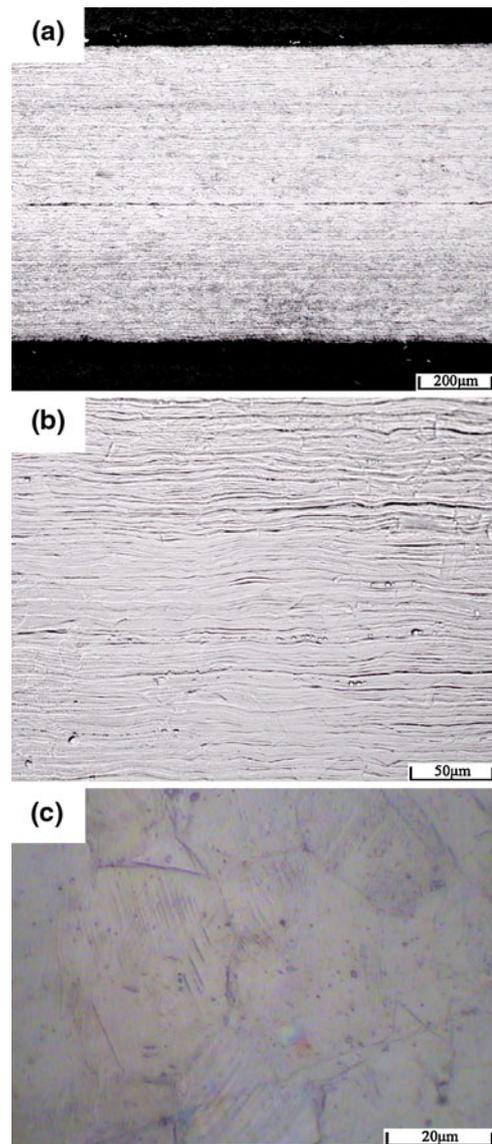
Fig. 3 Metallographic structure of fractured stainless steel belt's cross section: (a) cross section 100×, (b) center of cross section 500×, and (c) surface of stainless steel belt

It is well known that 300 series stainless steels commonly exhibit austenitic microstructures. However, as it is shown in Fig. 3, metallographic structure of the cross

section of the failed stainless steel belt is a mixture microstructure of both austenite and martensite which has a twisted fibrous morphology. Generally speaking, the

existence of martensite, which occurs at the inner part of austenite by means of strain-induced martensitic phase transformations, increases the hydrogen uptake because the hydrogen diffusion coefficient and permeability of martensite is higher than austenite [4]. Therefore, the martensitic transformation products could act as a suitable medium for hydrogen to entry and transport in the stainless steel [5].

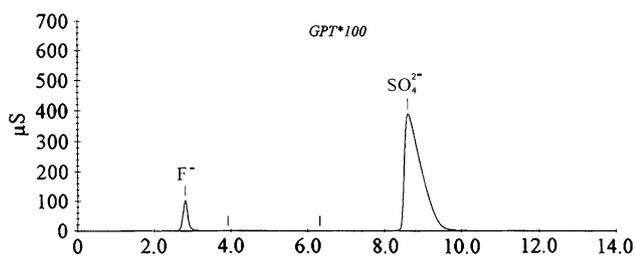
Ion chromatography was used to semi-quantitatively analyze the main anions in the solutions that the steel belts encounter, i.e., the deoxidation solution, the electrolytic deburring solution, and the deplating solution. In addition to the sulfate SO_4^{2-} which was detected in all three solutions, the fluoride anion F^- was particularly found in the deoxidation solution, as seen in Fig. 4. Commonly, SO_4^{2-} is a main component in the electroplating solution and is present as sulfuric acid. The F^- is a halide ion that is

Fig. 4 Chromatographic analysis result of deoxidation solution

known inducing corrosion on metals, especially pitting corrosion. However, it has been reported that a relatively high concentration of F^- will provide an inhibiting effect to the pitting corrosion of carbon steels [6]. In this case, the concentration of F^- is 6.4 g/l and may explain why there was no obvious evidence of pitting corrosion on the stainless steel belt.

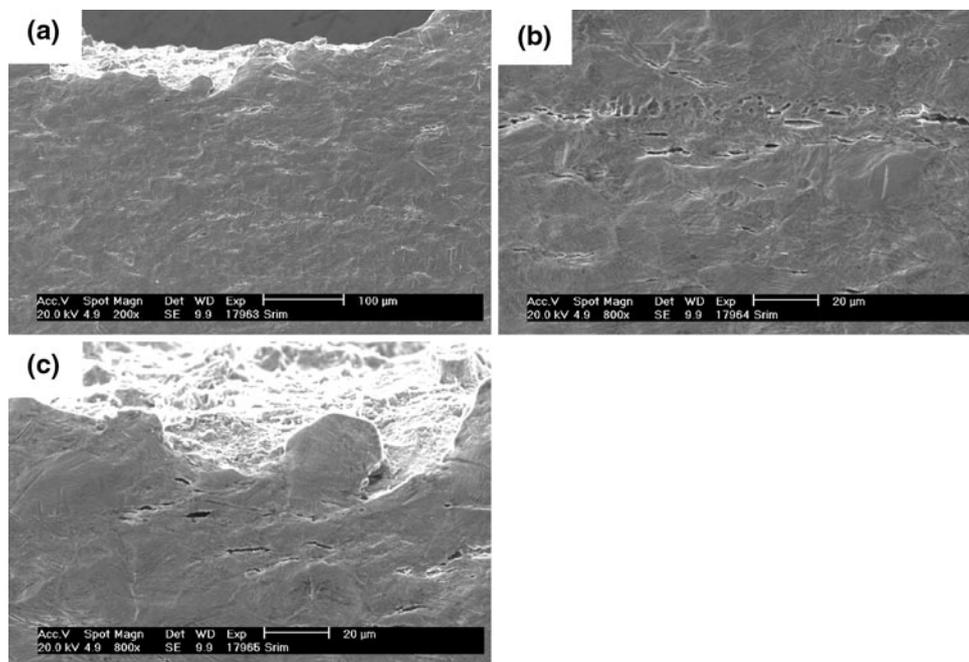
Fig. 5 SEM micrograph of defects in fractured belt bracket surface: (a) morphology of belt bracket surface, (b) enlarged local region, and (c) enlarged side of fracture

Figure 5 displays the SEM micrographs of the surface of the failed stainless steel belts and compares that surface to the normal surface morphology. Regularly distributed micro cracks and pits can be clearly found in Fig. 5b and c and are absent in Fig. 5a. Additionally, there are linear cracks parallel to the fracture, and some of these cracks

have connected to form a larger one. Moreover, a peculiar morphology of step-shaped crack group found on the surface is the typical feature of hydrogen-induced stepwise cracking (HISC). According to the EDS result shown in Fig. 6, it can be seen that no chlorine and fluorine elements were found on the surface of the failed steel belts, which indicates that halide-induced pitting corrosion should not be blamed for the emergence of the pits on the surface. Hence, it can be further identified that pits around the micro cracks were caused by hydrogen blistering (HB). To sum up, all the above observations are relevant to hydrogen embrittlement of the stainless steel belt which reduced its properties and eventually resulted in fracture [7].

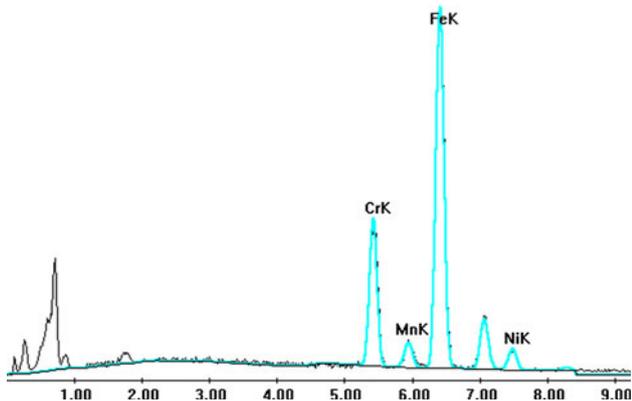
Fig. 6 Result of EDS

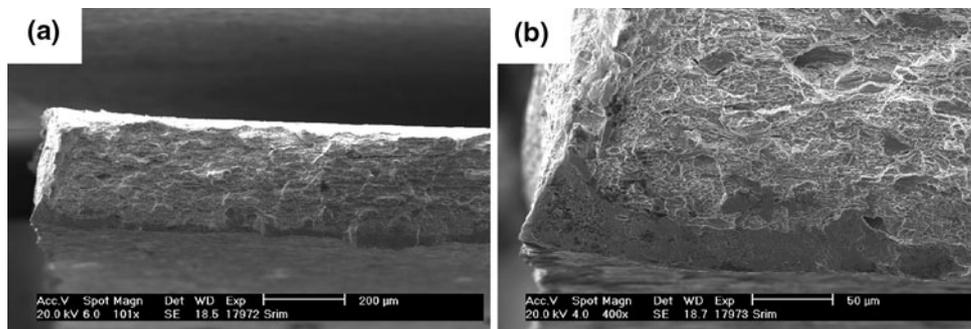
Fig. 7 SEM micrograph of fracture surface of belt bracket: (a) fracture surface of belt bracket and (b) enlarge the left part

In Fig. 7a, a flat cross section can be observed on the fracture. This fracture topography is generally a sign of macroscopically brittle fracture and is consistent with the failure mechanism of hydrogen embrittlement. Additionally, a long dark strip with even smoother surface is seen on the bottom of the fracture, Fig. 7b. This is a typical morphology of erosion, and then it can be inferred that the ultimate fracture of the steel belts may also involve the high-pressure water washing procedure.

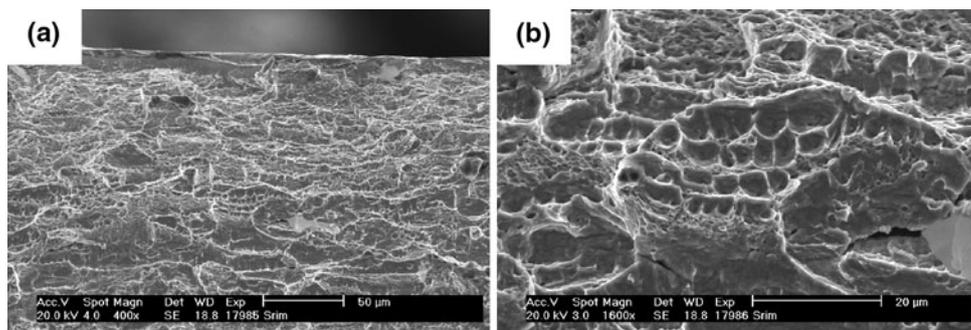
Fig. 8 SEM micrograph of stainless steel belt’s fracture: (a) expended morphology of stainless steel belt’s fracture and (b) dimples showing expended direction

Both obvious cleavage steps and dimples can be found in Fig. 8a. However, the cleavage steps cover most of the cross section, while the dimples were found only in the middle part of the cross section, seen in Fig. 8b. This phenomenon is consistent with fracture of the steel belts by hydrogen embrittlement with the embrittlement process being initiated from the outer surfaces of the belt.

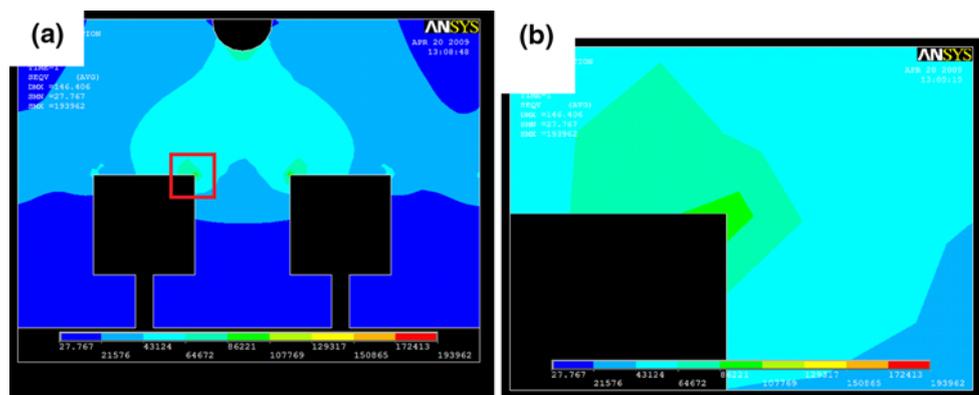
of the belt was set zero as the boundary conditions. According to the calculated results summarized in Fig. 10a, the stress concentrates on the corner of the bracket and its maximum value is about 8×10^4 MPa, Fig. 10b. This maximum stress value far exceeds the anticipated yield strength of the stainless steel component and must have contributed to the fracture.

Fig. 10 Stress distribution on the stainless steel after water washing: (a) FEM calculated result and (b) enlarged view of the bracket's corner

- (1) Materials with superior corrosion resistance such as 316L stainless steel or duplex stainless steel are suggested as replacements for the 301 and even the 304 stainless steel as the belt's matrix materials.
- (2) Technological parameters for the tin plating process must be optimized. The current density during activation and deoxidation steps, and pressure of the washing water should be appropriately reduced.
