# Failure analysis of leakage on titanium tubes within heat exchangers in a nuclear power plant.

## Part I: Electrochemical corrosion

Z.-G. Yang\*, Y. Gong and J.-Z. Yuan

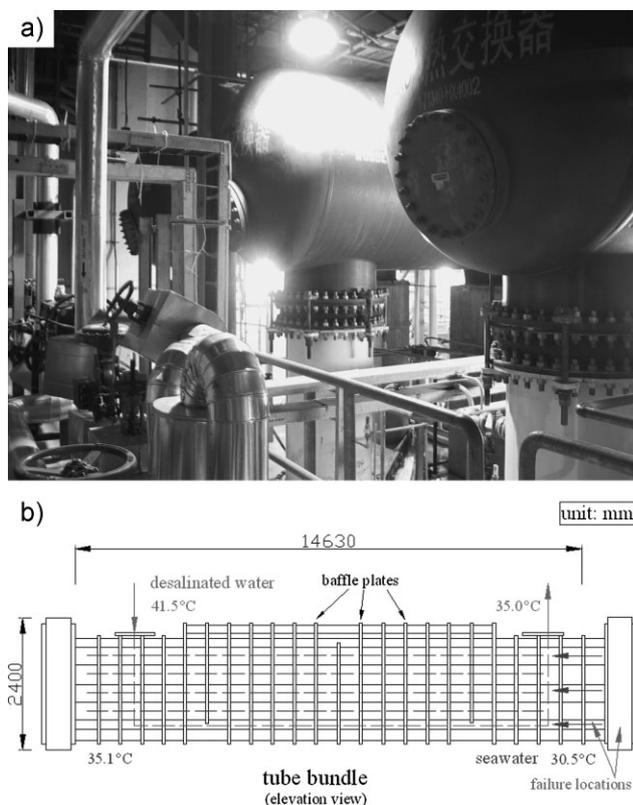
As shown in Fig. 1(a), the RCW heat exchanger is a horizontal cylinder with dimension of about  $\varphi 2400 \times 15\,000$  mm, in which there exist totally 4932 tubes (ASME SB-338 Gr.2 titanium [12],  $\varphi 19 \times 14\,630 \times 0.71$  mm) in 57 rows and 93 columns. All the tubes are sustained by 23 16 mm-thick carbon steel baffle plates with interval distance of 603 mm, and their two ends were

**Figure 1.** Illustration of the RCW heat exchanger: (a) external appearance, (b) scheme and operation parameters

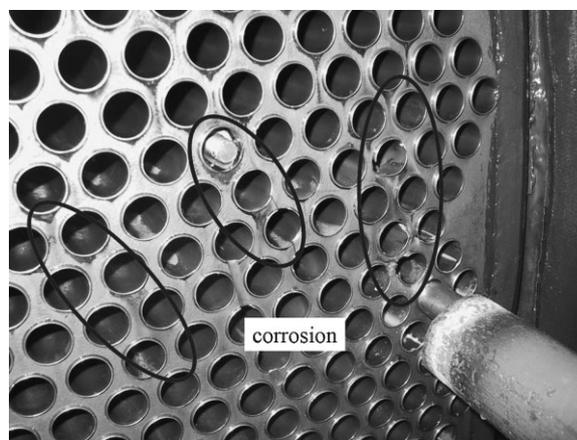
The two target leaked tubes analyzed in the present study were both sampled from the 4# RCW heat exchanger of unit II, which suffered the severest degradations on its tubes among all the eight heat exchangers in the two CANDU 6 units – 113 tubes were found to be heavily thinned, and another 24 tubes were even leaked. Furthermore, the ruptures on over 90% of the leaked tubes were located between the first baffle plate and the 78 mm-thick tube sheet, and even buried inside this tube sheet, also seen in Fig. 1(b). Meanwhile, as indicated with the circles in Fig. 2, obvious brown corrosion phenomenon was observed on the surface of the tube sheet itself as well.

**Figure 2.** Corrosion on the inlet of the tube sheet

left less than 0.5 mm gaps in some places of the tubes due to unsymmetrically hydraulically expanding, as seen in Fig. 2. As a result, seawater was provided with access into the shell side from the inlet of the tubes, and simultaneously introducing chloride ions. Then, these chloride ions would particularly accumulate in the gaps between the 78 mm-thick tube sheet and the titanium tubes, and gradually concentrate on the outside wall surfaces of the titanium tubes under the gaps, eventually initiating crevice corrosion [23] as well as galvanic corrosion.

Based on cause analysis for this failure, a simple, effective countermeasure was proposed, i.e., special polymer resin sealants must be coated on the inlet surface of the tube sheet to fill possible 0.5 mm gaps between the tubes and the plates. As a result, the galvanic corrosion and crevice corrosion, as well as subsequent HAC were thus eliminated. Afterward, the bulges caused by electrochemical corrosion did not occur any more in the routine inspection of next few years.

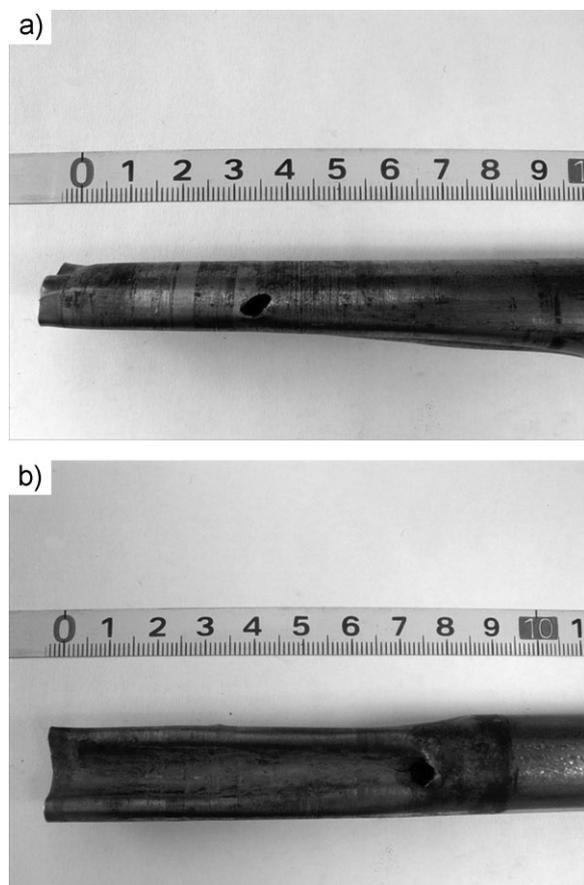
Figure 3 presents the external appearances of the two leaked tubes named A and B from this heat exchanger. As shown in Fig. 3(a), the rupture on tube A was in shape of  $5 \times 3$  mm ellipse and located about 30 mm off the inlet. While for the rupture on tube B, it seemed relatively round with a diameter of nearly 6 mm, and was 70 mm off the inlet, seen in Fig. 3(b). Hereby, it must be noted that both the distances of the two ruptures off the tube inlets were less than 78 mm, i.e., they were both formed buried inside the tube sheet.

**Figure 3.** External appearances of the ruptures on the two leaked tubes: (a) tube A, (b) tube B

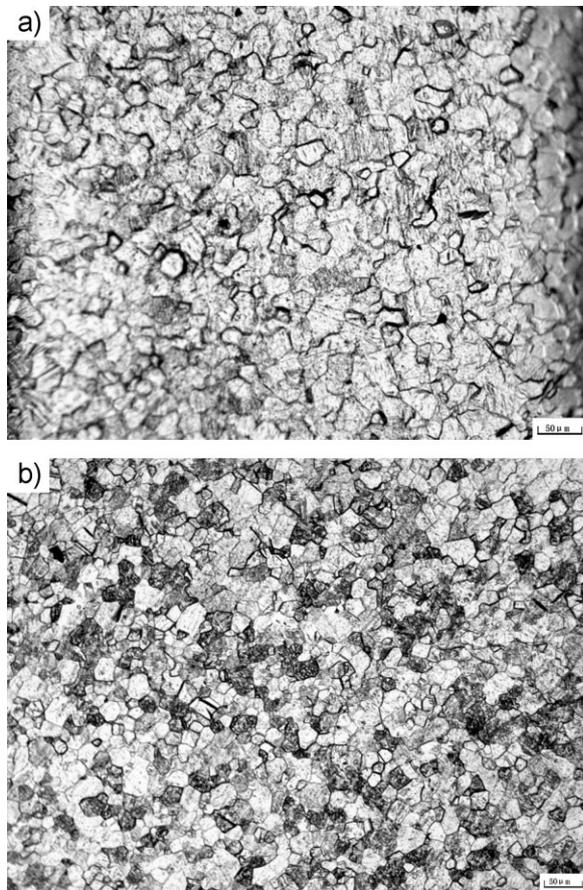
Figure 4(a) and (b) show the metallographic structures of the titanium tubes in, respectively, transverse and longitudinal directions. It is obvious that the structures in both directions display a similar morphology, i.e., equiaxed polygonal grains – the typical structure of  $\alpha$ -titanium, and their average ASTM grain size is about 8. It should be also pointed out that the sizes of these grains are basically even, without excessively coarsened or fined.

**Figure 4.** Metallographic structures of the titanium tubes: (a) transverse, (b) longitudinal

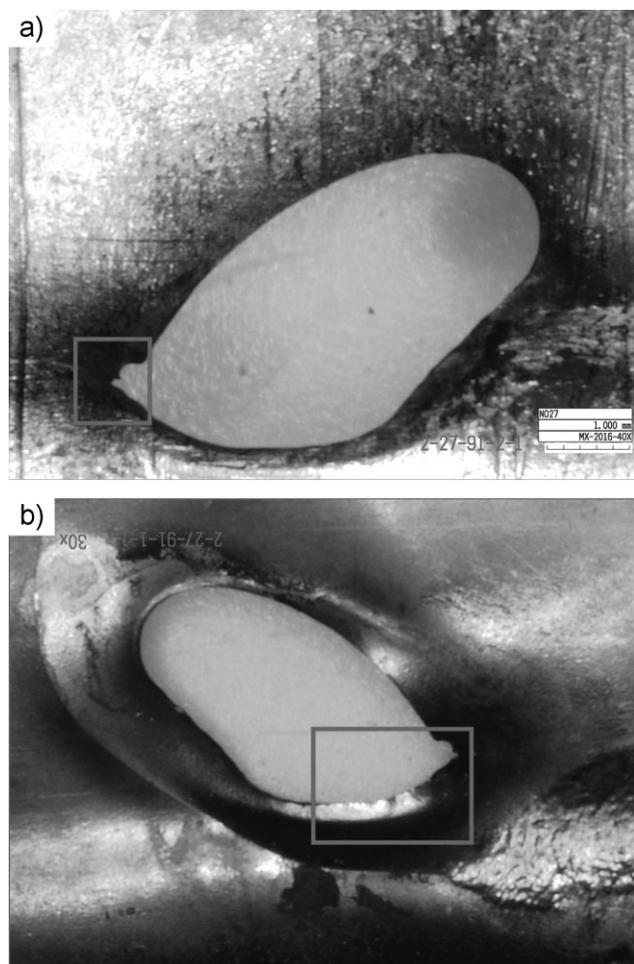
After magnifying the rupture in Fig. 3(a), it can be obviously learnt from Fig. 5(a) that the fringes of this rupture were bent inwards to the inside wall, which may be attributed to a relatively large force exerting on the outside wall of the tube. Meanwhile, brown colored rust covered around this rupture, which should be the corrosion products of iron oxides originated from the Ti/carbon steel tube sheet. The inside wall around the rupture was pretty smooth, and the extent of rusting was not as severe as that on the outside wall too [Fig. 5(b)].

**Figure 5.** Macroscopic morphologies of the rupture on tube A: (a) outside wall, (b) inside wall

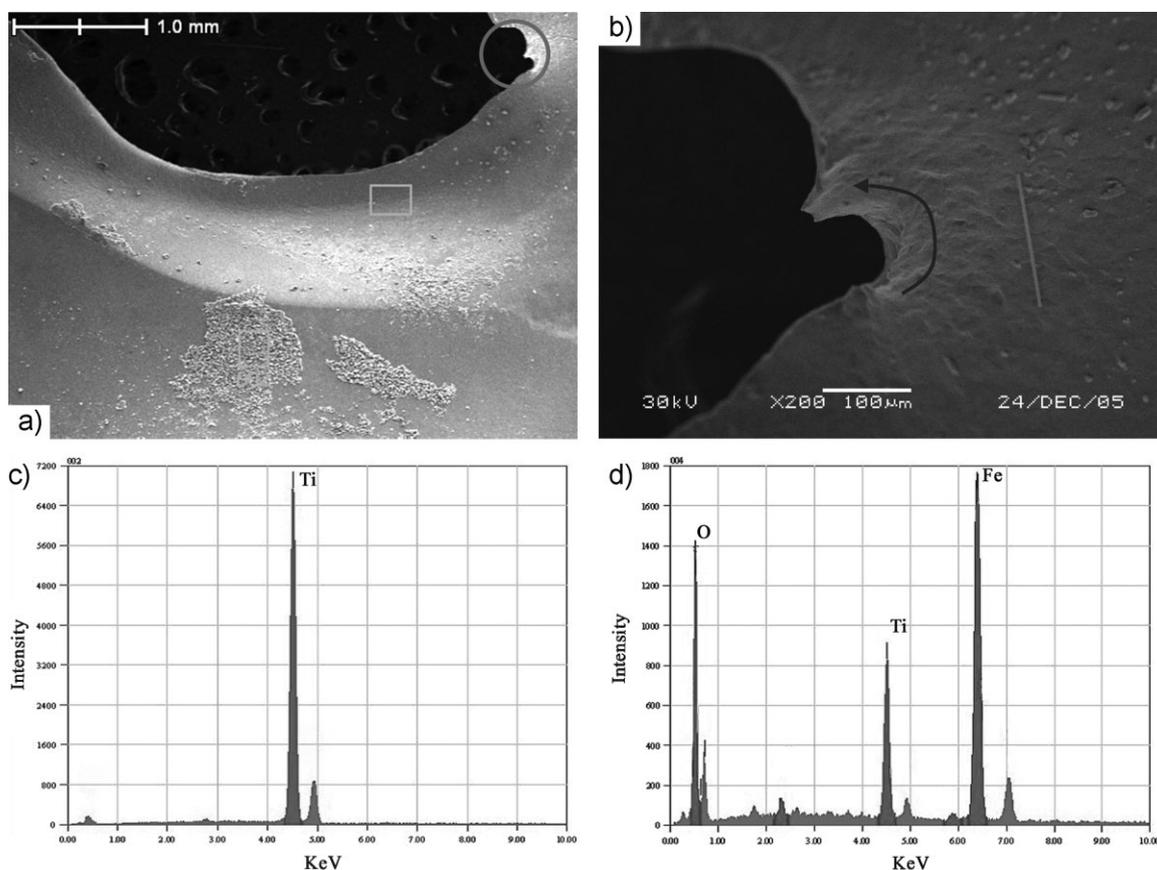
Under SEM, microscopic morphology of the area marked with rectangular in Fig. 5(b) was presented in Fig. 6(a). Besides the smooth fringe (site 001), some corrosion substances (site 002) were also scaling on the inside wall of the rupture. By means of EDS, the former one was exactly the titanium matrix material of the tube [Fig. 6(c)], while the latter one actually also contained iron and oxygen elements other than titanium [Fig. 6(d)]. It can be inferred that such corrosion substances were introduced from the outside wall of the tube after the rupture was formed. Furthermore, it must be particularly noted that the corner of the inside wall exhibited an unusual morphology seeming like oriented eddy erosion, seen in Fig. 6(b). Just due to this erosion effect, almost no corrosion substances were scaling around the corner, completely contrast to the site 002 in Fig. 6(a). Also, another significant evidence also revealed that densely distributed pits existed near the corner with eddy erosion trace. This fact means that such kind of erosion was even accompanied with impact because of the sediment particles contained in the natural

**Figure 6.** SEM morphologies and EDS of the inside wall of the rupture on tube A: (a) rupture fringe, (b) evidence of eddy erosion, (c) EDS of site 001, (d) EDS of site 002

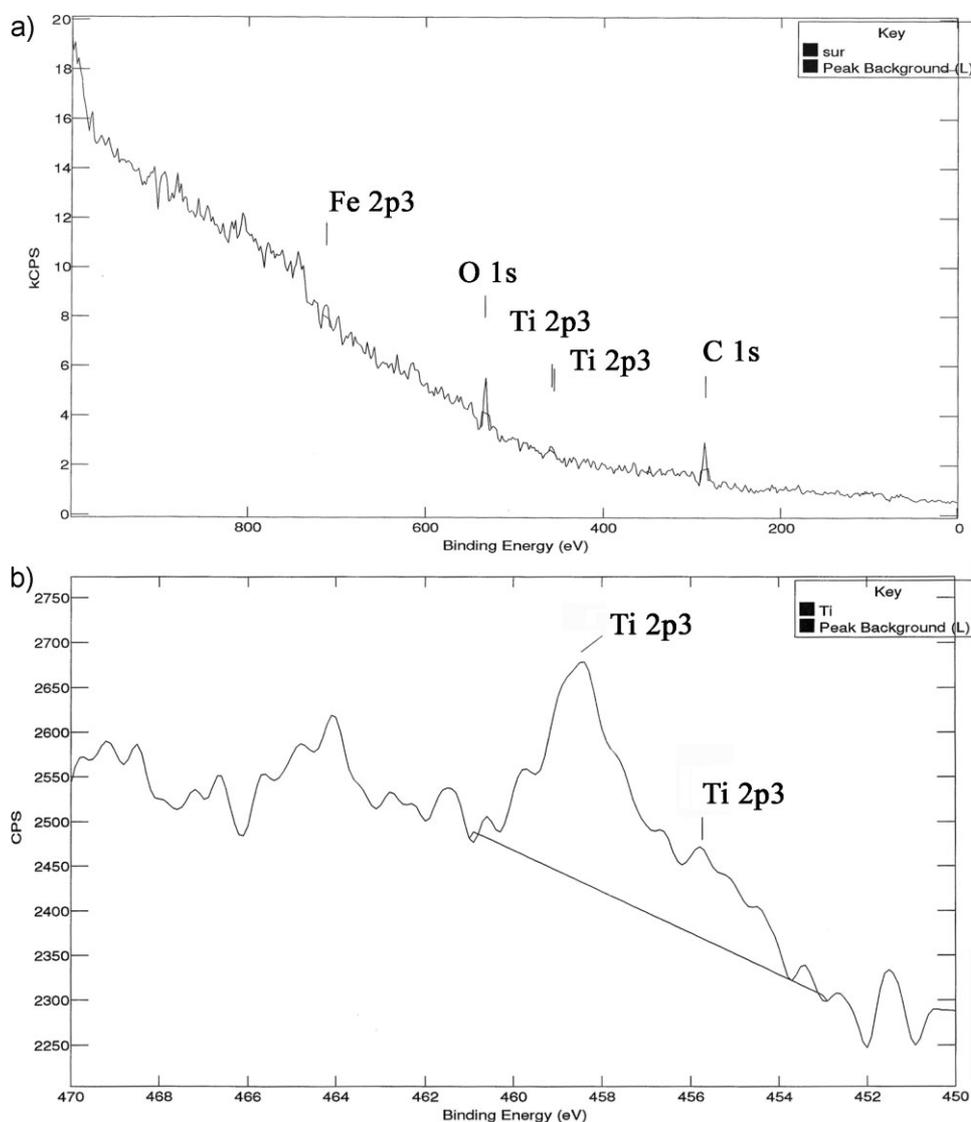
For the purpose of characterizing the surface features of both the outside wall and the inside wall near the rupture, XPS was utilized to determine the chemical valences of relevant elements. As shown in Fig. 7(a), totally four kinds of main elements were present on the outside wall, among them the two metal elements should be paid special attention to since they were from the matrix materials of the tube and the plate. The electron binding energy of iron was 711.80 eV, which corresponded to the compound FeO(OH) [17]. However for titanium, it had two close spectra, that is to say two species of chemical valences existed. After locally magnifying [Fig. 7(b)], the binding energy of the left one was 458.48 eV, while that of the right one was 455.74 eV. Referring to the handbook [17], the former one represented TiO<sub>2</sub>, however the latter one could not correspond to any compound. In other words, an irregular chemical valence was introduced on the titanium due to corrosion, and needed subsequent analysis.

Figure 7. XPS results of the outside wall near the rupture on tube A: (a) all elements, (b) titanium

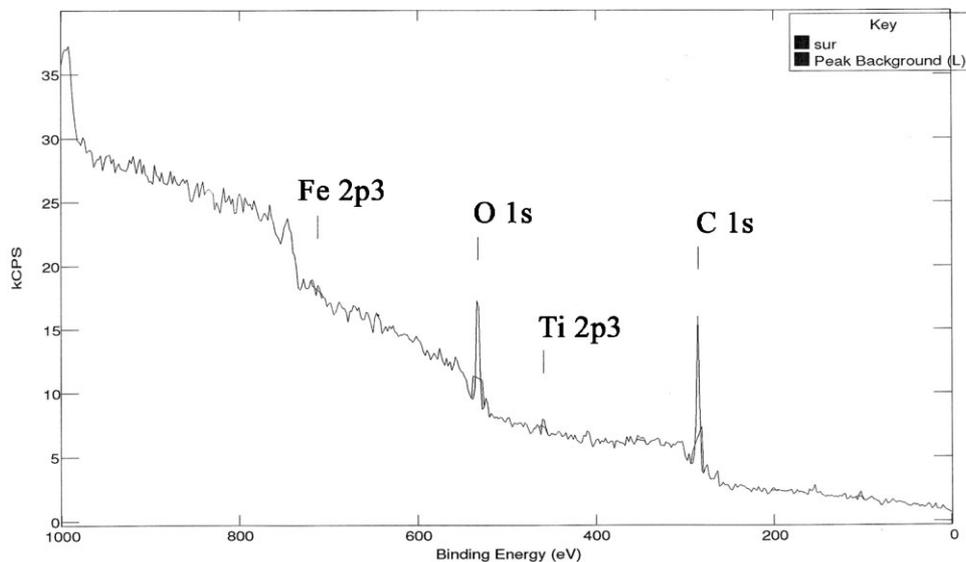
711.80 eV, i.e., the FeO(OH) (Fig. 8); as for the titanium, there was only one titanium spectrum here, and its binding energy was 458.53 eV, i.e., the TiO<sub>2</sub>. Now it can be confirmed that some kind of corrosion which would bring about an irregular chemical valence on titanium only occurred on the outside wall of the tube, and was probably related to the unknown force exerting on the tube.

Figure 8. XPS results of the inside wall near the rupture on tube A

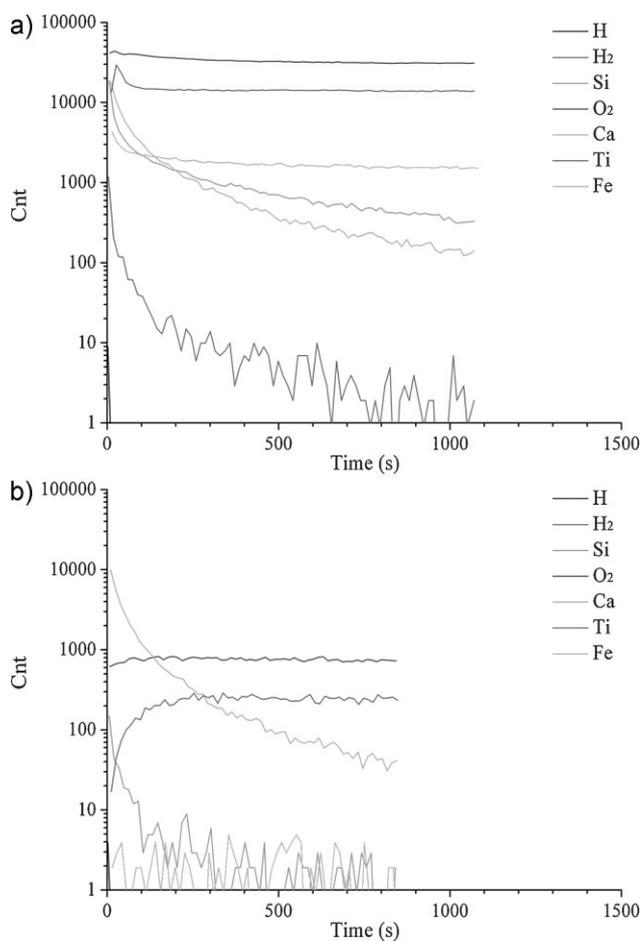
Considering the well-known fact that titanium exhibits strong interaction with hydrogen [18], thus the titanium with irregular chemical covalence on the outside wall near the rupture was possibly related to the hydrogen element, which can only be sensitively detected by surface analysis technique SIMS [19]. As displayed in Fig. 9(a), hydrogen element in form of H<sub>2</sub> gas was indeed present, while it did not exist on the inside wall in contrast, seen in Fig. 9(b). This result verified the conclusion we put forward above that corrosion only took place on the outside wall of the tube, and it was very probably the HAC. However, it still needs further method to determine the actual chemical compositions of the titanium hydrides.

Figure 9. SIMS results of the areas near the rupture on tube A: (a) outside wall, (b) inside wall

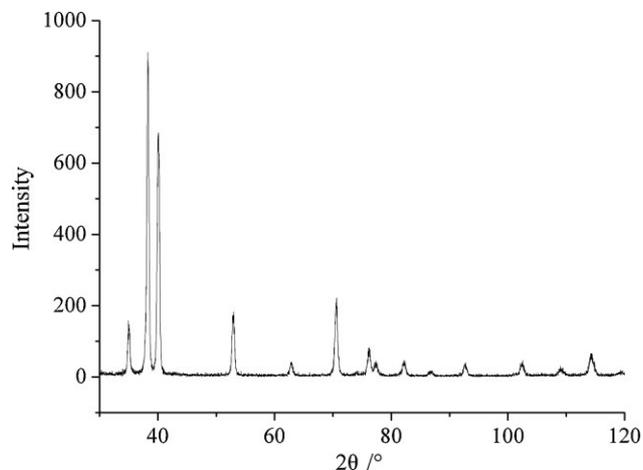
It is clearly shown in Fig. 10 that a kind of crystalline with irregular stoichiometric number as TiH<sub>1.924</sub> was present other than pure titanium near the rupture. Then, the actual chemical composition of the titanium hydride can be finally ascertained. In fact, the peak of TiH<sub>1.924</sub> can be regarded as TiH<sub>2</sub> [20], the product of hydrogen absorption reaction.

Figure 10. XRD results of the area near the rupture on tube A

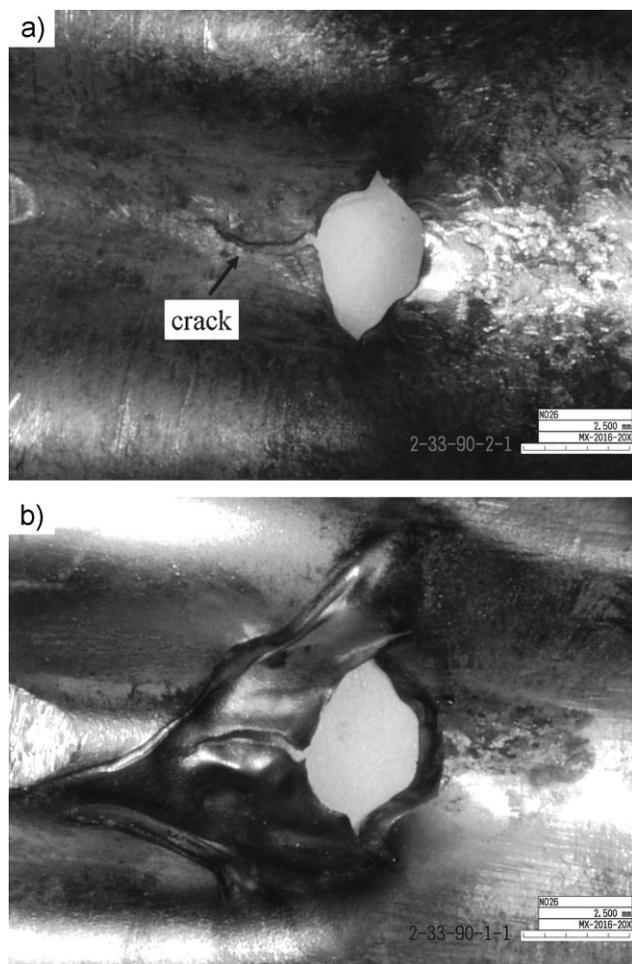
As shown in Fig. 11(a), a crack with length of 3 mm was engendered from the rupture along the axial direction of the tube and exhibited brittle fracture morphology, while the inside wall near the crack was even seriously deformed, seen in Fig. 11(b). Similar to that on tube A, the rupture fringes here were also bent inwards to the inside wall but with severer extent. So it can be judged that the two ruptures on both tubes A and B were aroused by the same cause, but the degradation extent on tube B was severer than that on tube A.

**Figure 11.** Macroscopic morphologies of the rupture on tube B: (a) outside wall, (b) inside wall

the other degradation as HE was also aroused by the presence of  $TiH_x$  on the titanium tubes in this event. The value of  $x$  usually ranges from 1.5 to 2.0 with respect to the thickness of the titanium hydride, and the surface is commonly  $TiH_2$  [32].  $TiH_2$  is an absolutely brittle compound in fcc (face-centered cubic) structure [33, 34], and its thickness will keep growing with the increase of hydrogen concentration in it. Once the thickness exceeds a critical value, cracks always in brittle mode are brought about [32], i.e. the HE [35], which was distinctly observed in Fig. 11 on the titanium tube with eligible strength and toughness.

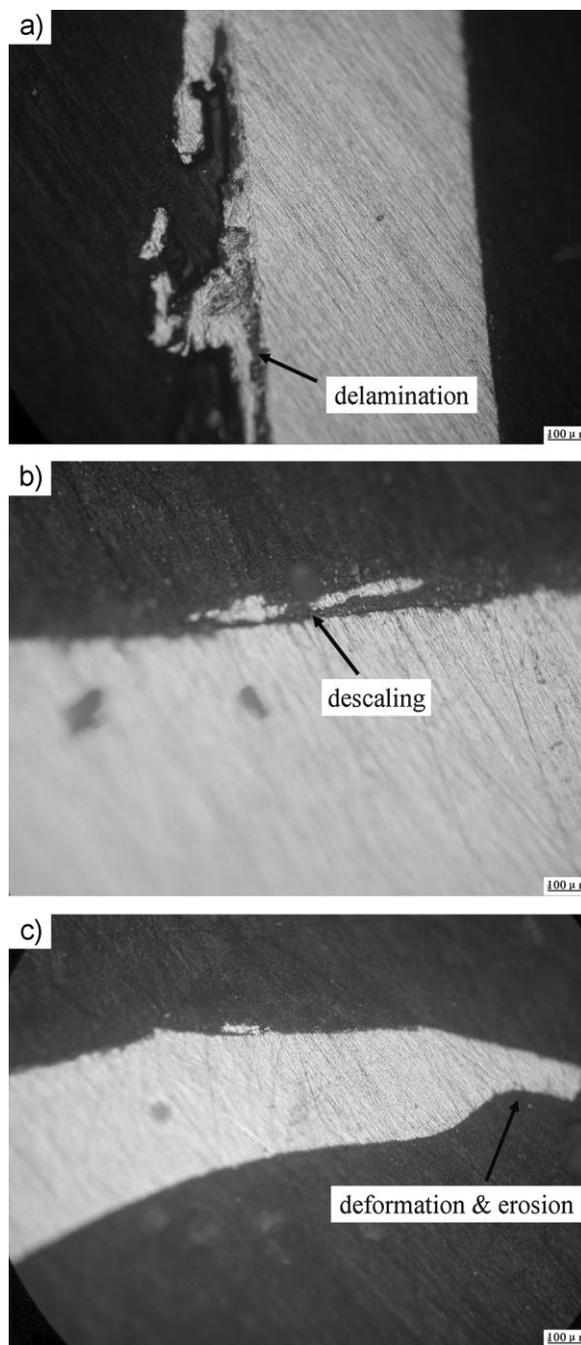
Consequently, similar microscopic analysis and near-surface characterization were not needed to conduct again on tube B. Instead, cross-sections of the rupture were observed. Figure 12(a) and (b) illustrated that the surface of the outside wall was deteriorated so severe that both delamination and descaling occurred on it, which were the evidence of crevice corrosion. On the contrary, the inside wall of the tube was really smooth, seen in Fig. 12(a). However, the fringe of the rupture was seriously thinned due to the erosion effect from the seawater containing sediment particles, see Fig. 12(c).

**Figure 12.** Cross-sections of the rupture on tube B: (a) delamination of matrix material, (b) descaling of matrix material, (c) thinned by erosion

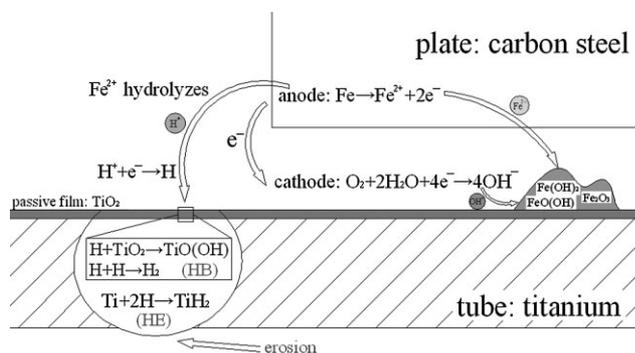
Generally, the standard electrode potentials of pure titanium and pure iron are  $-1.63$  and  $-0.44$  V, respectively [21], i.e., the titanium will serve as the anode to be corroded when it is in this galvanic pair. However, it is also a common sense that passive film  $\text{TiO}_2$  will be spontaneously formed when pure titanium is exposed to the air, and increases the potential. As a result, the potential of titanium shifts to about  $0.0$  V [22]. In fact, the potential of carbon steel which contains the carbon/iron galvanic pair is also lower than pure iron, at about  $-0.60$  V [22]. Consequently, if the titanium and the carbon steel are connected, carbon steel will act as the anode to be corroded. In this event, such kind of galvanic corrosion was exactly observed on the carbon steel plate in Fig. 2, whose half-cell as well as total reactions are listed in Equation (1), and the schematic diagram is presented in Fig. 13.

**Figure 13.** Schematic diagram of the mechanisms of electrochemical corrosions and HAC on titanium tubes

Now it can be briefly summarized that since there existed less than 0.5mm gap between the titanium tubes and carbon steel plate due to unsymmetrically hydraulically expanding and unsealed welding on the inlet of tube sheet, galvanic corrosion and crevice corrosion naturally happened in the gap zone under penetration of seawater. Then, the HAC including HB and HE was induced on the outside wall of the tube, leading to a localized bulge inwards to the inside wall of the tube. In the following, the sustaining erosion from seawater containing sediment particles in the tube side was exerted on the bulge. The bulge wall was thus gradually thinned and finally ruptured.
