# Engineering Failure Analysis

## Failure analysis of one peculiar ‘Yin-Yang’ corrosion morphology on heat exchanger tubes in purified terephthalic acid (PTA) dryer

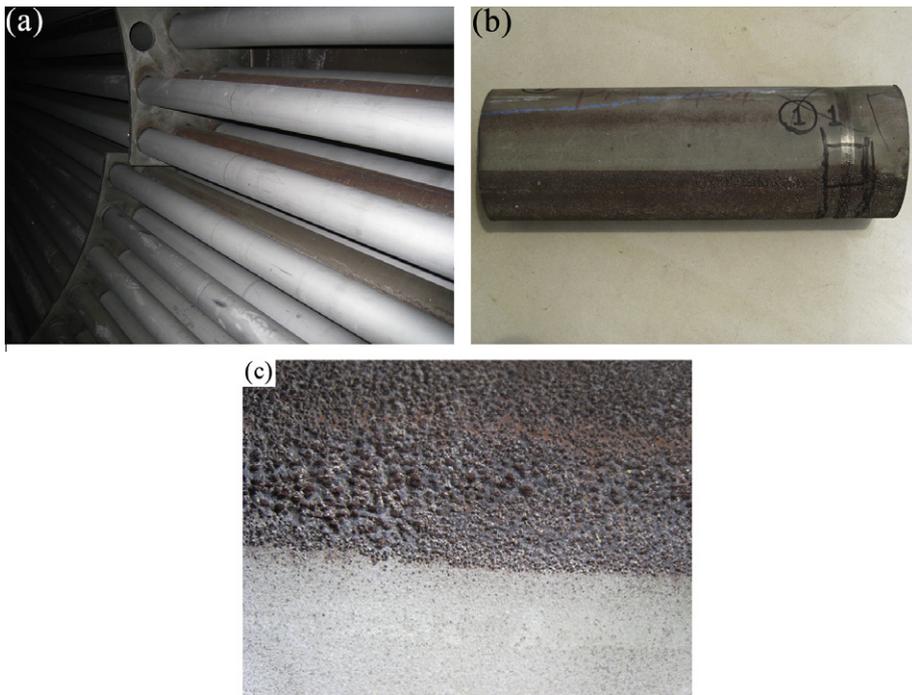
As revealed in Fig. 2a, corrosion failure only occurred on the second array, i.e. the 4-in. tubes, of all the three arrays of heat exchanger tubes inside the PTA dryer. After sampling, Fig. 2b displayed the external appearance of the above-mentioned ‘Yin-Yang’ corrosion morphology on one failed tube, and on its surface the horizontal boundary line between the ‘Yin’ and the ‘Yang’ faces could be clearly observed. Further magnified, the corroded ‘Yin’ face was actually covered with densely distributed corrosion pits, seen in Fig. 2c, implying a localized corrosion mechanism.

**Fig. 2.** External appearances of the 'Yin-Yang' corrosion morphology on failed tubes. (a) Only on 4-in. tubes, (b) boundary line between 'Yin' and 'Yang' faces, (c) corrosion pits.

1. Concentration of the chloride ions in NaOH alkaline wash liquor should be limited under 30 ppm to avoid pitting.
2. Amount of the catalysts that contain bromine element in the oxidation unit should be strictly controlled.
3. Surface conditions of the 4-in. tubes must be inspected, and adequate treatment should be carried out if necessary.

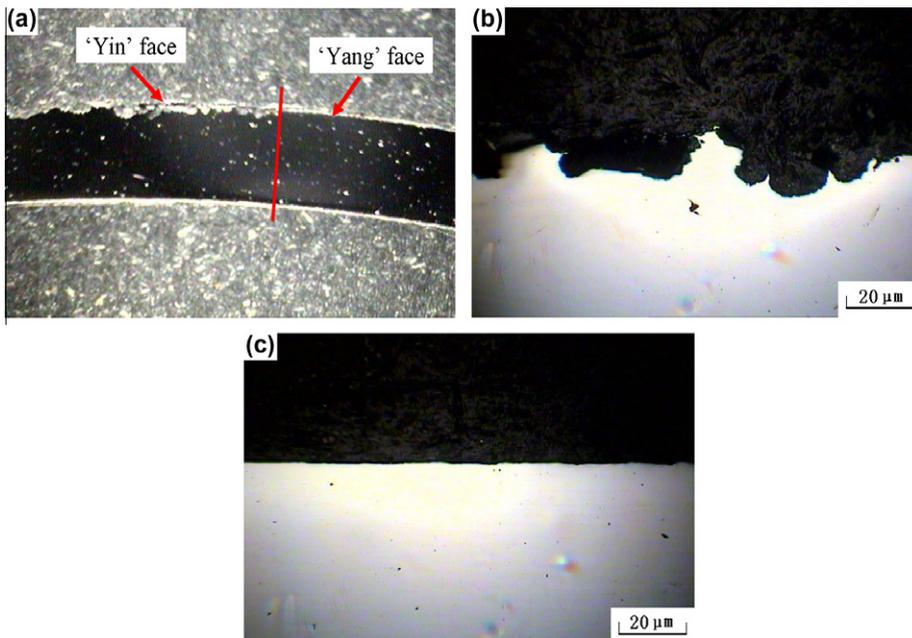
For purpose of obviously comparing the two different ‘Yin’ and ‘Yang’ faces of the failed tube, Fig. 3 presented the microscopic morphologies of its cross-section. As shown in Fig. 3a, a fictitious boundary line could be drawn between the left ‘Yin’ and the right ‘Yang’ faces. Further magnified, the ‘Yin’ face was composed of corrosion concaves and pits, seen in Fig. 3b, while contrarily, the ‘Yang’ face was relatively smooth without any significant defects, seen in Fig. 3c.

**Fig. 3.** Microscopic morphologies of the failed tube cross-section: (a) total, (b) 'Yin' face, (c) 'Yang' face.

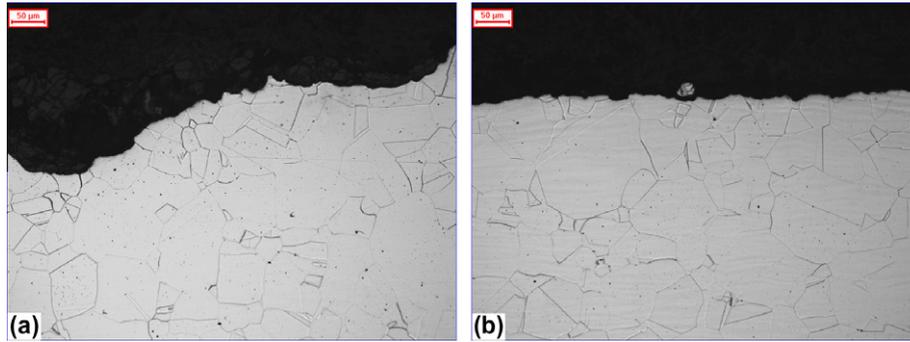
**Fig. 4.** Metallographic structures of the failed tube, 200× (a) 'Yin' face, (b) 'Yang' face.

Fig. 4a and b displayed the metallographic structures of the 'Yin' and the 'Yang' faces respectively of the failed tube, both exhibiting typical austenitic structures with average grain size of about 6. However, it should be particularly pointed out that lots of dot-like inclusions existed within the grains, basically composed of MnS and silicon oxides, and would probably act as the initiating sites of localized corrosions when being exposed to aggressive environments [12]. Although, the material could be regarded qualified in general.

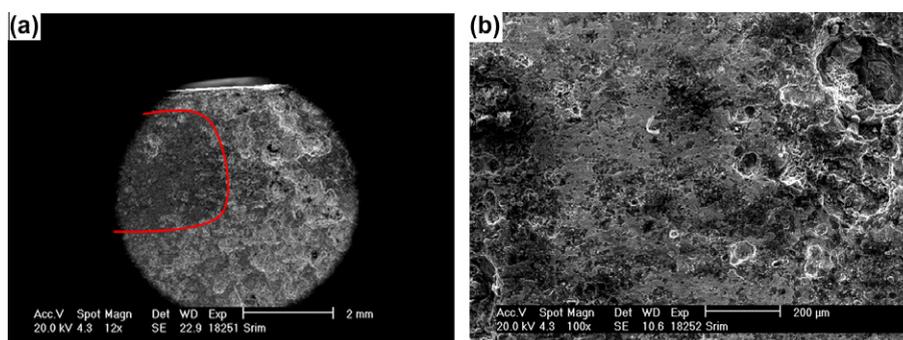
At first, surface of the failed tube with ‘Yin-Yang’ corrosion was observed under SEM. As shown in Fig. 6a, a distinct boundary line, just like that in Fig. 3a, could be easily marked between the ‘Yin’ and the ‘Yang’ faces. After magnification, lots of corrosion pits with maximum size of about  $200\ \mu\text{m}$  were found on the ‘Yin’ face, seen in Fig. 6b, exhibiting the familiar morphology of localized corrosions, especially pitting.

Fig. 6. SEM micrograph of the ‘Yin-Yang’ corrosion on failed tubes. (a) Boundary line between ‘Yin’ and ‘Yang’ faces (b) corrosion pits on ‘Yin’ face.

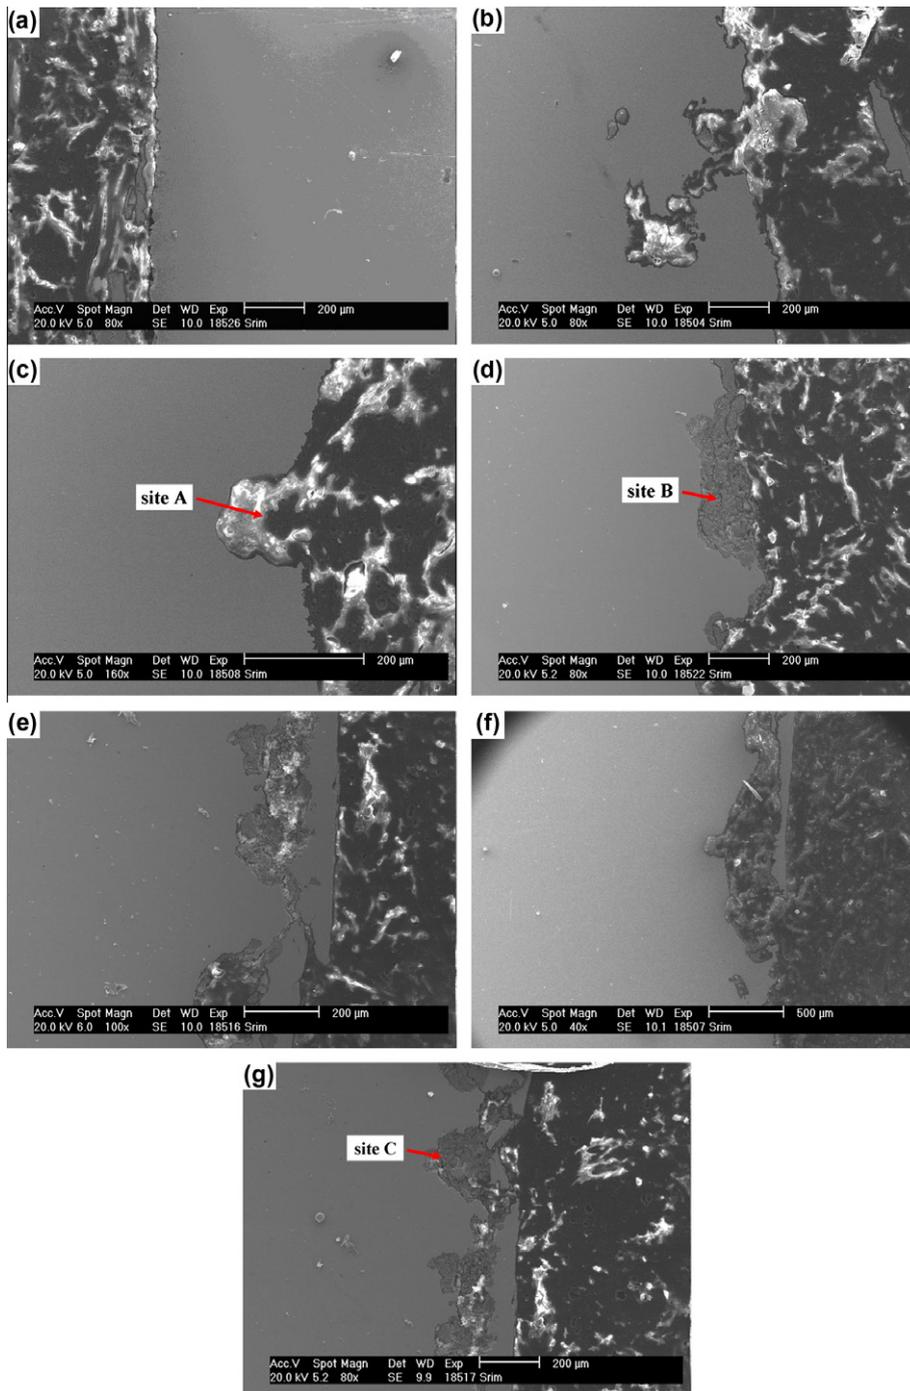
Actually, after being cut off, the cross-sections of the ‘Yin’ face further verified it was ascribed to the pitting corrosion indeed. Compared with the smooth ‘Yang’ face (Fig. 7a), the corroded ‘Yin’ face was provided with a variety of typical morphologies of pitting corrosion in theory [14], including narrow & deep (Fig. 7b), elliptical (Fig. 7c), wide & shallow (Fig. 7d), subsurface (Fig. 7e), undercutting (Fig. 7f), and horizontal (Fig. 7g). What’s more, based on the EDS results, aggressive bromide and chloride ions were detected on the corrosion products within such pits too, seen in Fig. 8 and Table 2. As mentioned above, the bromine element was the remnant from the catalyst in the oxidation reaction, nevertheless the actual source of the chlorine element still needed to be determined. Anyway, all these facts had already sufficiently demonstrated that the peculiar ‘Yin-Yang’ corrosion was led by the halide-ions-induced pitting corrosion, and its mechanisms would be discussed in detail as follows.

**Fig. 7.** SEM micrograph of cross-section of the 'Yin-Yang' corrosion on failed tubes. (a) 'Yang' face, (b) narrow & deep, (c) elliptical, (d) wide & shallow, (e) subsurface, (f) undercutting, and (g) horizontal.

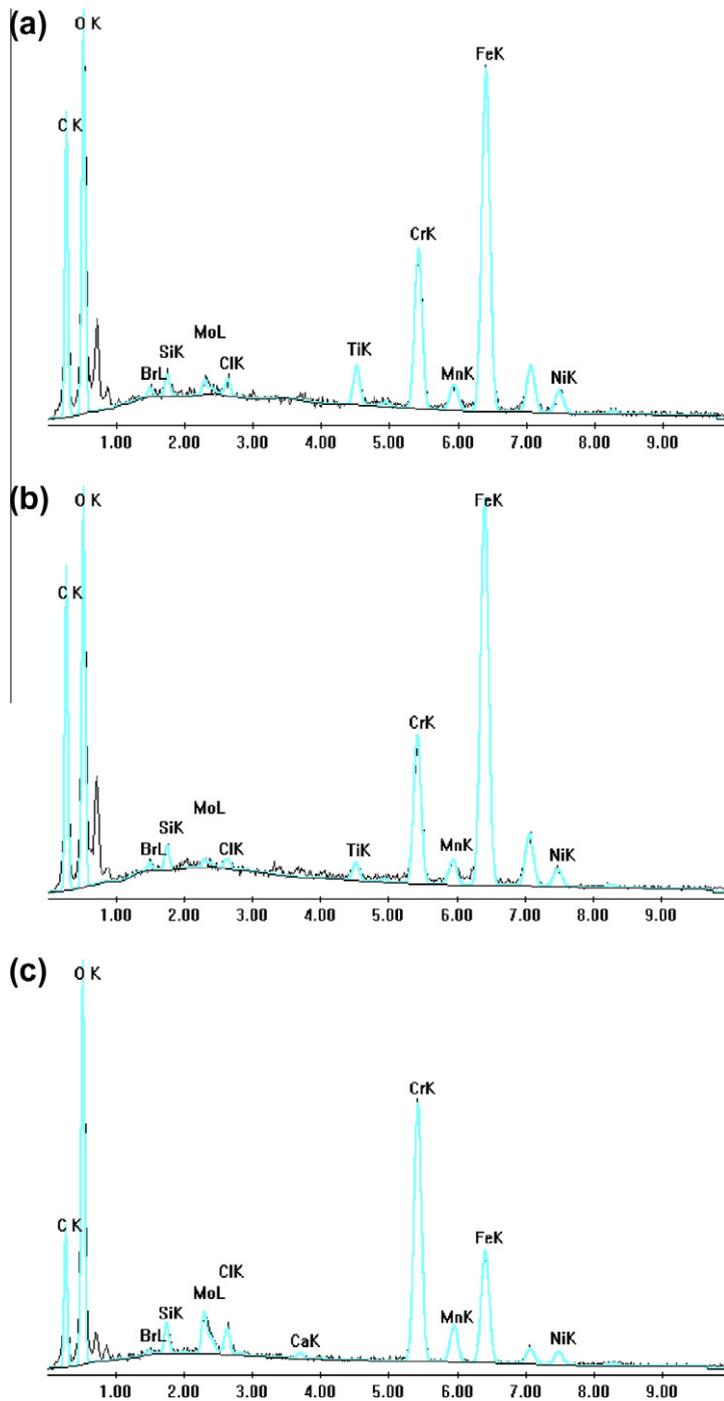
Fig. 8. EDS results of the corrosion products within pits (a) site A, (b) site B, and (c) site C.
