Failure Analysis on Blind Vias of PCB for Novel Mobile Phones

Abstract Failure of blind via is one of the main causes of an open circuit in printed circuit boards (PCBs). By using macroscopic and microscopic testing methods and characterization techniques, the failure analysis of the vias on PCB for novel mobile phones has been systematically carried out. Metallographic inspection shows obvious cracking along the interface of different copper layers. Micrograph observation and chemical analysis on the grain boundary have definitely identified that inappropriate location of the vias concerned with circuit design and residue sulfur related to incomplete desmear process predominantly account for cracking of blind vias, and the occurrence of the cracking is caused by the formation of a brittle Cu_xS layer. Moreover, the influence of warpage on the reliability of the via was noted. Based on these defaults, improvement countermeasures and suggestions are addressed in the paper and are of significant value for reference to the safe reliability and structural integrity of PCB products during manufacturing and services.

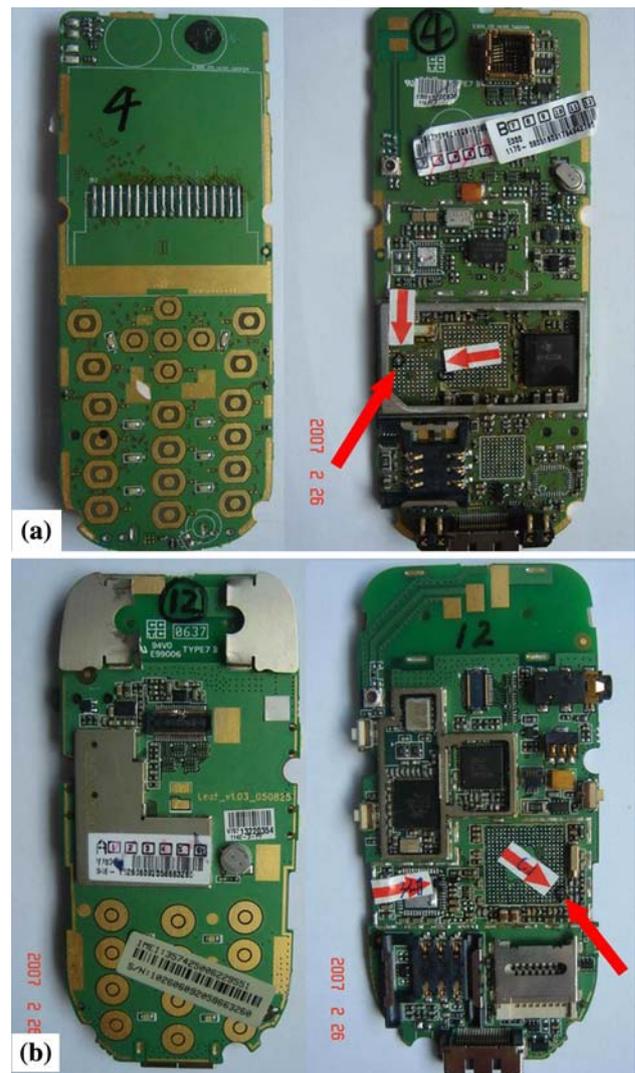
Figure 1 shows the circuit configuration of both sides with components on two types of PCBs, respectively, with dimension of $92 \times 37 \times 1.1$ mm for type 1 and $81 \times 38 \times 0.98$ mm for type 2. Open-circuit faults have been detected mainly around BGA solder joints and solder bars of several components and chips by automatic optical inspection (AOI). The faults induce failure of the whole board. During macroscopic inspection, circuit configurations of components on type 1 PCB are not distorted, but obvious warpage has been found in type 2 PCB. Modern analytic instruments and characterization methods have been adopted in order to find the primary causes.

Fig. 1 Circuit configuration with components on PCBs. (a) Front and back face of Type 1 PCB. (b) Front and back face of Type 2 PCB

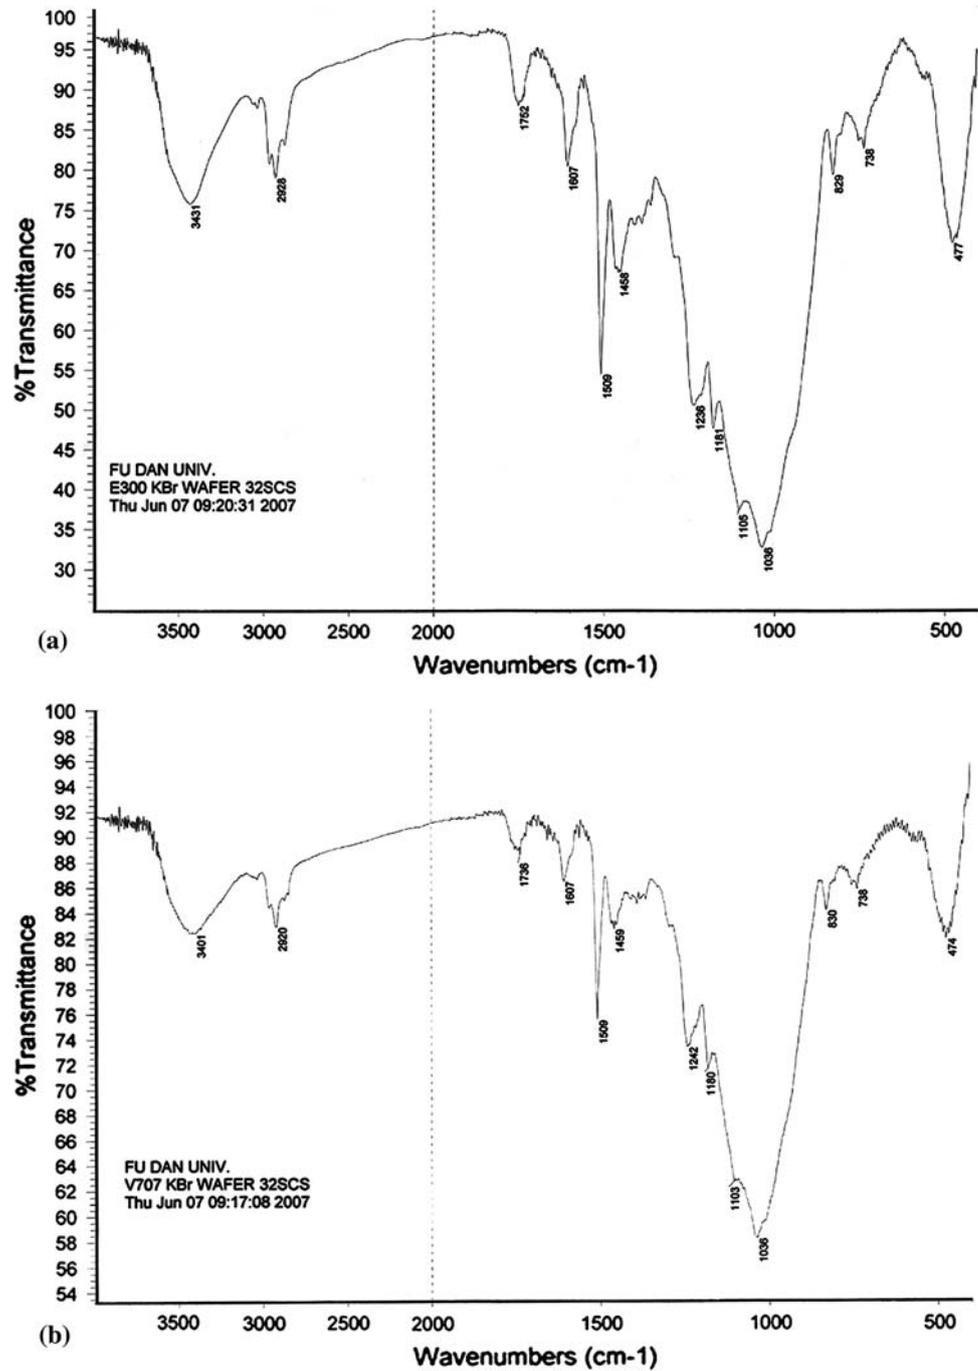
The results of FT-IR (Fig. 2) show that the two types of PCB have an FR-4 flame-resistant substrate and that the raw materials are all bromized epoxy resin. TGA curves in Fig. 3 indicate that the materials reach their thermal decomposition temperature (T_d) at about 323 °C. The T_d of bromized epoxy resin is generally above 300 °C, and the soldering peak temperature in surface mounting technology (SMT) of PCB is below 270 °C. Therefore, the raw materials can endure the instantaneous high temperature and the failure should have no relationship to the soldering processes.

Fig. 2 FT-IR spectra of bare board. (a) Type 1. (b) Type 2

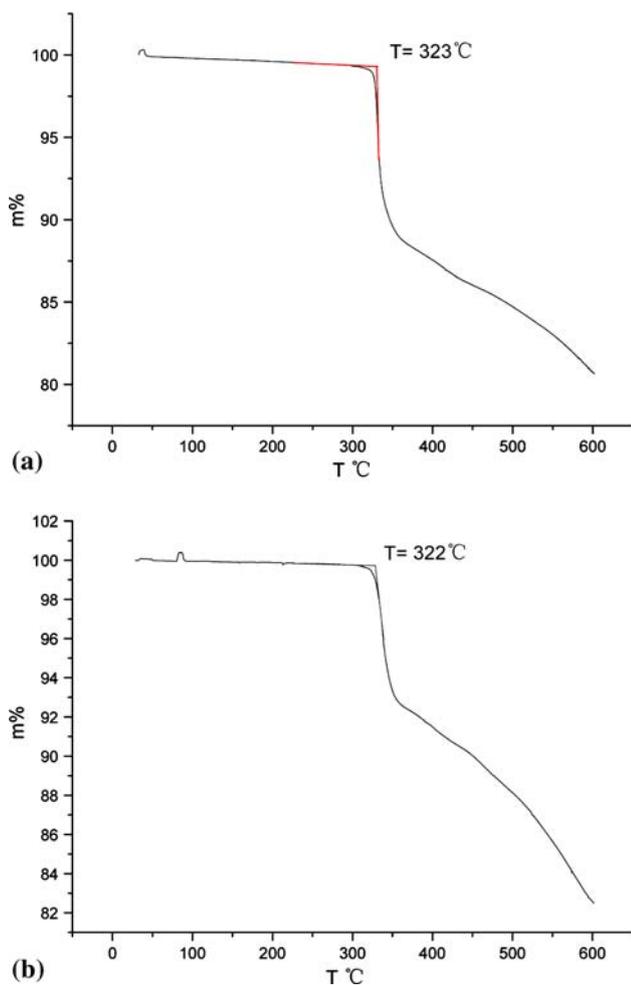
Fig. 3 TGA curve of bare board. (a) Type 1. (b) Type 2

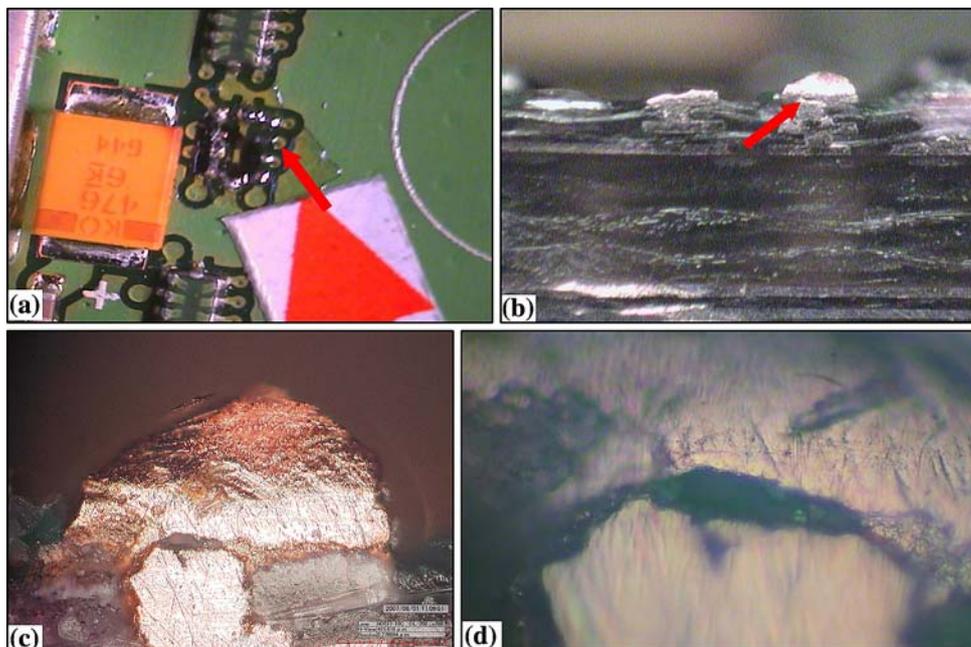
Microscopic study was carried out at low magnification using stereomicroscope and at higher magnification using OM and 3D. Figures 4 and 5, respectively, present the morphologies of the failure blind vias on both types of PCBs. From Fig. 4(c) and (d), distinct cracking can be seen between the copper plating layer and the pad of the blind via. As illustrated in Fig. 4(b), the pad is not located right in the center of the via. Consequently, a strong thermal stress will occur around part of the via, leading to an asymmetric thermal deformation under conditions of

reflow soldering or service. Moreover, the mismatch of coefficient of thermal expansion (CTE) between the plating layer and copper foil will enhance the thermal stress, finally resulting in the fracture from one side of the via. The location of the blind via in Fig. 5 indicates that the via and the BGA solder pad are too close to each other, just like the case shown in Fig. 4. An obvious microvoid in the copper foil, in which there appeared to be some debris, and an apparent crack in the bottom of the via, are displayed in Fig. 5(c) and (d).

Fig. 4 (a) Location of the failure blind via (type 1). (b) Appearance of the via. 4.5× (c) and (d) Cracking morphologies by 3D and OM. 40× and 60×

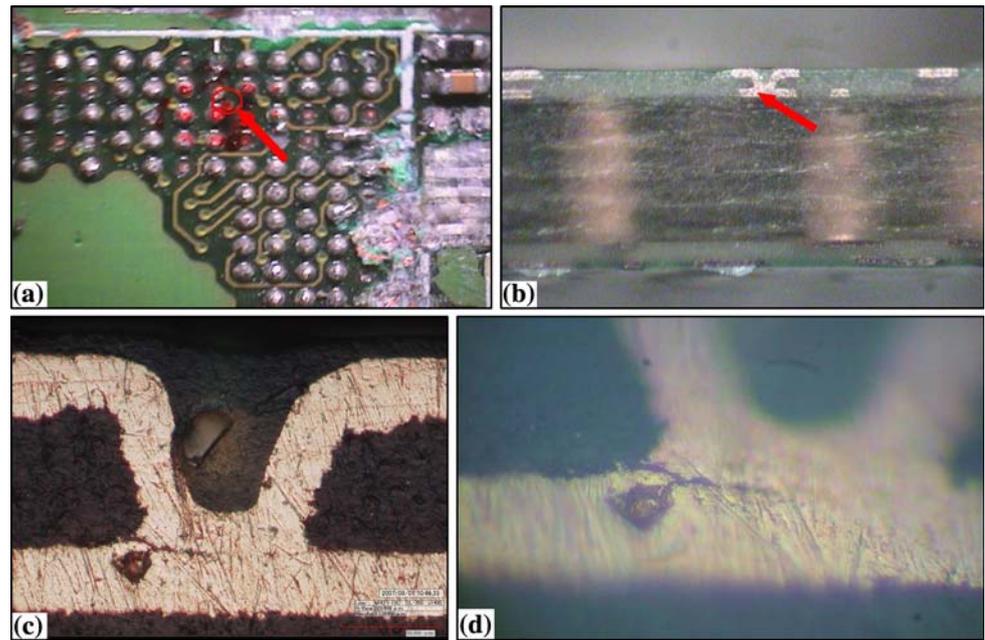
Fig. 5 (a) Location of the failure blind via (type 2). (b) Appearance of the via 4.5×. (c) and (d) Cracking morphologies by 3D and OM. 40× and 60×

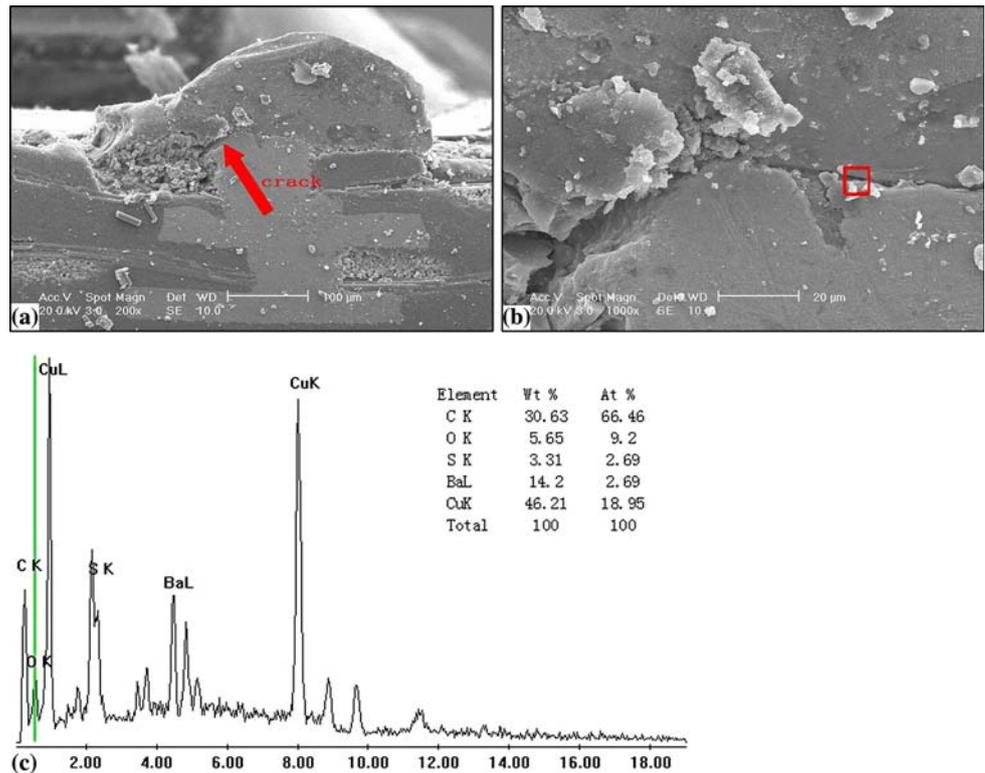
A big open cracking from one side of the blind via with a result of a separation completely between the pad and the copper-plating layer is shown in Fig. 6. An obvious cracking from the bottom of the other blind via that partly separated the via and the copper foil is presented in Fig. 7. We can also notice from the location of these two blind vias that the design position between pads and blind vias is somewhat improper. They are not kept in the same Z-direction, and the distance between them is too small. Usually, the region close packed with deep color dots shows a comparatively faster rate of heating. Therefore, temperature around the pads covered with solder of dark color rises faster than pad areas without solder during the heating for reflow soldering; while temperature in the areas with just the pads drops faster than in those overlaid with solder in the cooling segment of reflow soldering. The mismatch CTE of these two areas results in a strong thermal stress and an asymmetric deformation in the blind via linked closely to the pad uncovered with solder. Accordingly, the improper circuit design regarding the location of blind vias and pads is the leading cause of vias cracking.

In addition, the EDS results (Fig. 6c and 7c) demonstrate that a certain amount of sulfur which usually leads to embrittlement concentrates at the interface. Higher magnifications of the cracking and many microcracks can be seen in Fig. 7(d)–(g). These microcracks are generated along the deposited copper grains. Microstructure of the grains near cracking has also been obtained by FIB, with a sound characteristic of intercrystalline fracture. It can be

Fig. 6 SEM-EDS results of the failure blind via. (a) SEM micrograph of blind via. (b) Morphology of the cracking. (c) EDS analysis of the element compositions in the crack

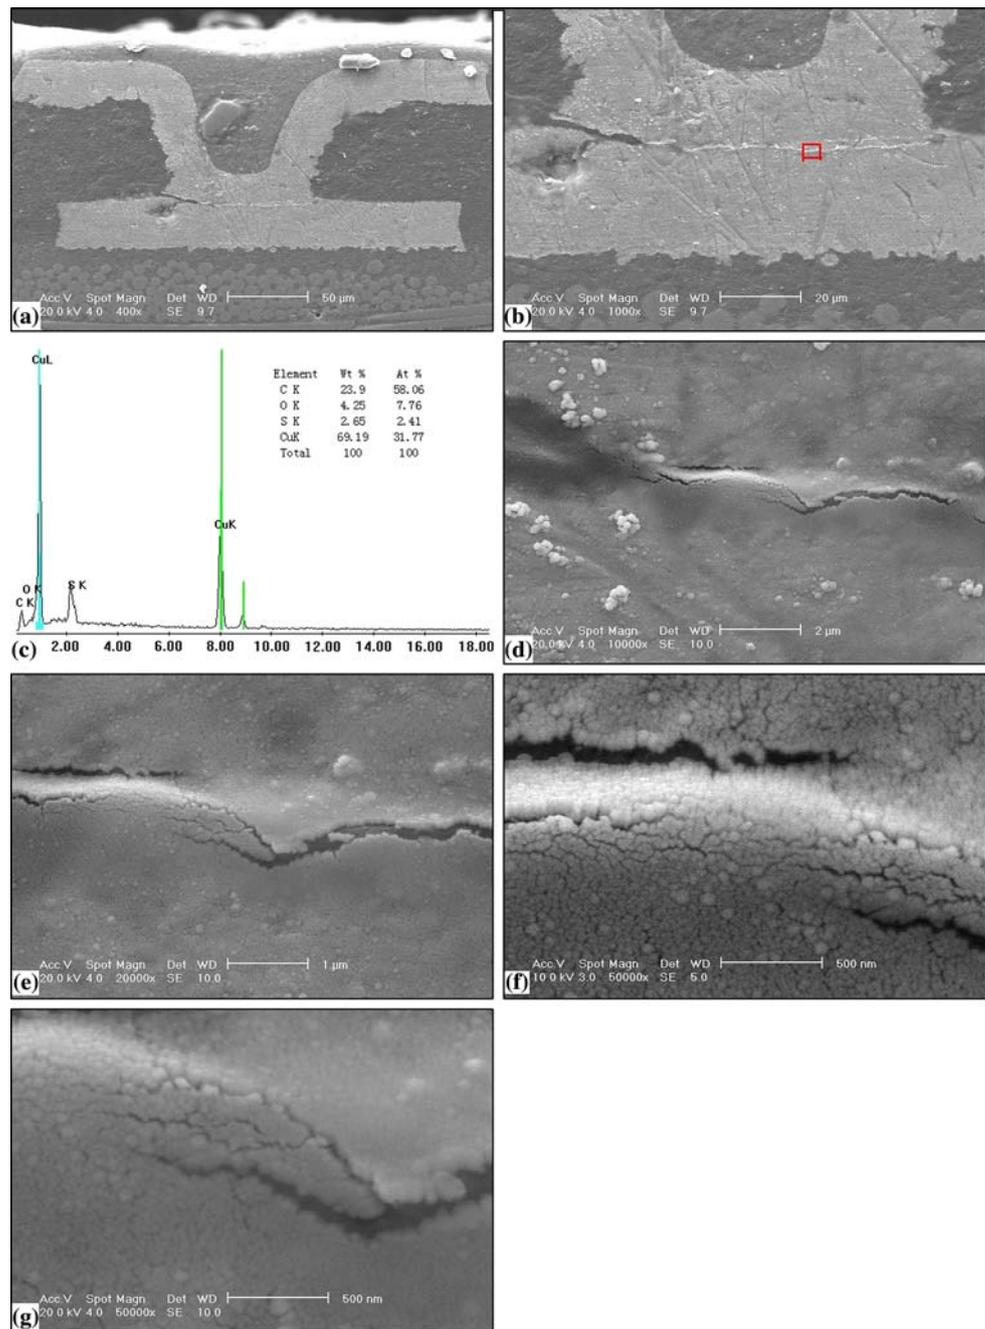
Fig. 7 SEM-EDS results of the failure blind via. (a) and (b) SEM micrographs of the via. (c) EDS analysis of the element compositions in the crack. (d)–(g) Morphologies of the cracking

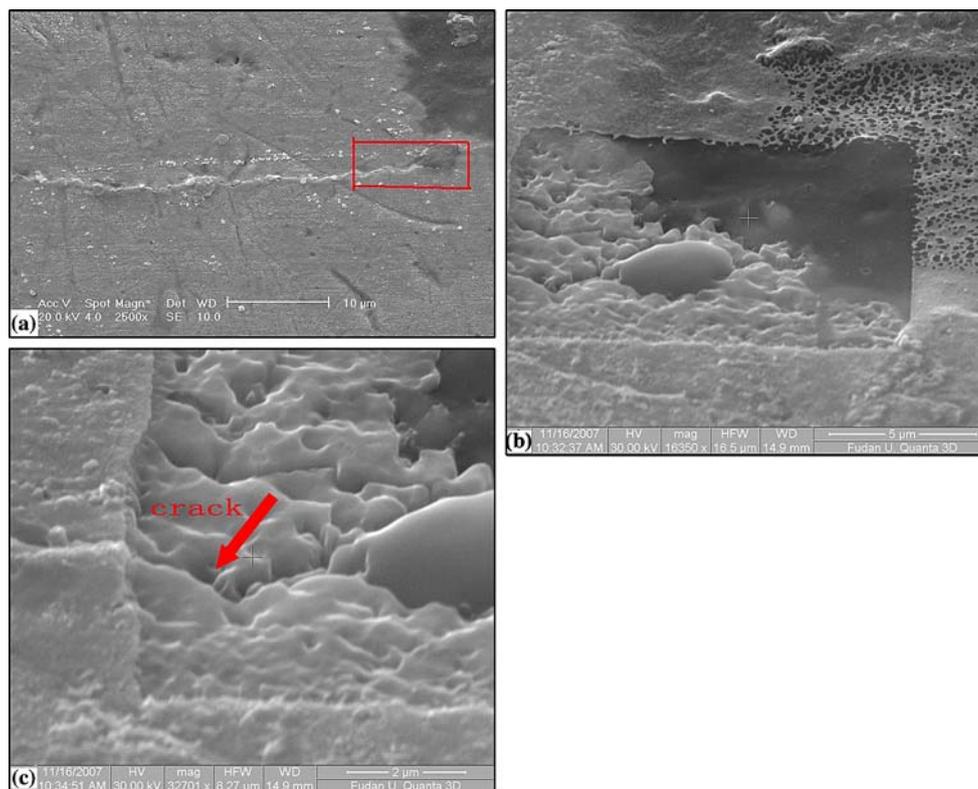
Fig. 8 FIB microstructure. (a) Etching section. (b) and (c) Morphologies of the cracking

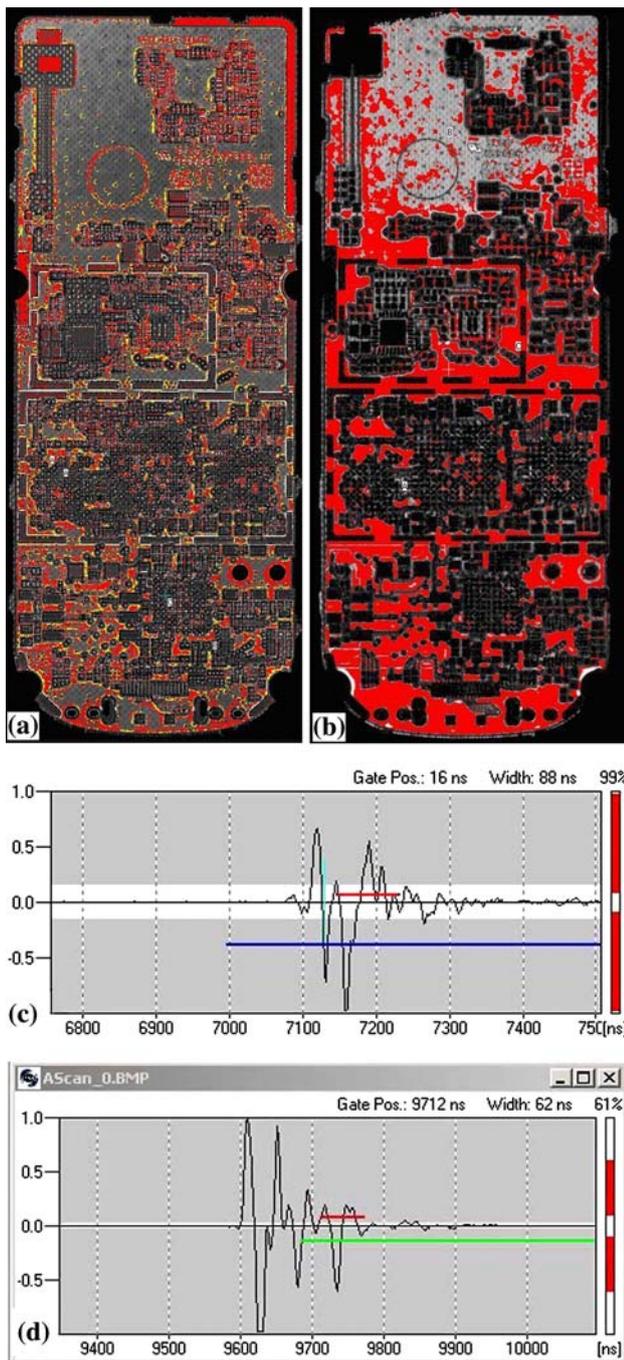
fatigue simulation testing to determine whether delamination influenced the reliability of resin-coated copper (RCC) foil. Testing conditions and parameters are listed in Table 1, and the delamination comparison of the bare board before and after the test is presented in Fig. 9. The results show that there is only a slight increase in the display of delamination on the whole board after the test and there is almost no noticeable delamination around the failure sections. Therefore, the open circuit is not caused by delamination.

Fig. 9 SAM inspection of the bare board before and after thermal cycle test. **(a)** Before testing. **(b)** After testing. **(c)** Spectra before testing. **(d)** Spectra after testing
