Damage and Residual Life Assessment of Bends for X20CrMoV12.1 Main Steam Pipe after Long-Term Service

Abstract The bent sections from a main steam pipe in a thermal power plant in Shanghai were examined after 165,000 h service at 550 °C under 13.73 MPa pressure. The residual life of the bend sections is determined by evaluation of the service stresses and testing to obtain creep rupture data. Metallographic analysis and tensile, impact, and hardness tests are also conducted. These combined tests show that the properties of the steel deteriorated during service, displaying embrittlement tendencies; the corresponding microstructures exhibit grain boundary weakening and creep damage characteristics. However, considering no evidence of localized damage in the form of creep cavitation or surface cracks was observed in the examined parts, considering the residual life of the bends at service condition, they are adequate for an additional 44,000 h of operation. It is recommended that a health assessment should be taken after 25,000 h service exposure for safety reasons.

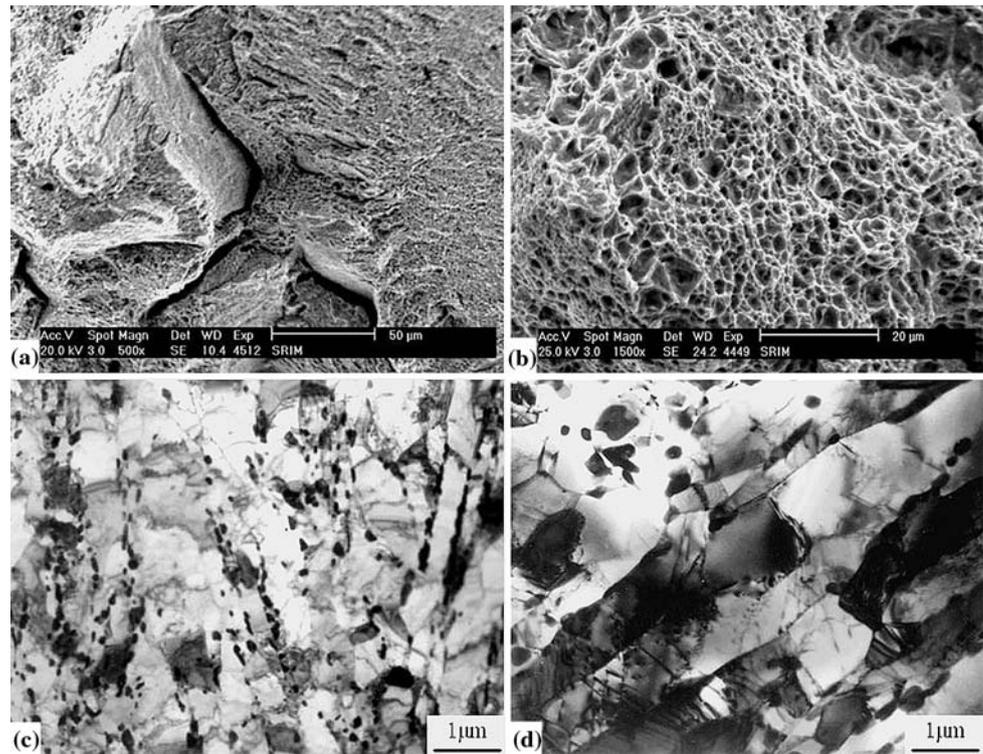
Scanning electron microscopy (SEM) was used to inspect the fracture surfaces of the test samples. Figure 1 (a) shows the fracture surfaces of tensile test from an exposed sample at room temperature. This sample displays almost complete intergranular fracture on a macroscopic level, although the fracture mode is ductile rupture. Subcracks propagate along grain boundaries, and wedge cracks appear at triple points. The fracture facets are quite flat, even though a process of tensile necking had taken place. Such fracture implies a weakness of the grain boundaries, which is caused by the segregation of phosphorus and the presence of coarsened carbides in the grain boundaries during long-term exposed service at high temperature [7]. Figure 1(b) shows the fracture surfaces of tensile test from the same exposed sample tested at 550 °C. It shows that the fracture was transgranular ductile rupture; however, a few subintergranular cracks can be seen in the fracture facets. These observations are consistent with the trend toward weakening of the grain boundaries with exposed time.

The general TEM microstructure of the sample is shown in Fig. 1(c). Obviously, the main structure is a typical tempered martensite containing laths and many coarsened carbide precipitates along grain boundaries. The ferrite regions appear very clean in the TEM image, and most regions contain some finer precipitates. No form of intergranular cavities was observed in the foil sample, but some evidence of creep damage can be seen in TEM. The shapes of the laths are changed; in particular, the lath boundaries look like bamboo knots, called cell structure, which is a typical microstructure morphology caused by creep [8]. Many low dislocation density regions appeared in the lath structure, and some typical substructures can be seen in Fig. 1(d). The substructure seems to develop as subgrains boundaries are formed by dislocation movement during the

Extensive carbide precipitates can be seen at prior austenite and martensite lath boundaries, with the finer precipitates in martensitic laths. Large coarsening carbides in irregular spheroid formed along the boundaries. Compared with virgin material, the carbide morphology coarsened distinctly.

The observations indicate that the matrix of the tempered martensite has undergone a deterioration during long-term creep. The dislocations climbed or glided and terminated at boundaries. As the number of dislocations at the boundaries increased, networks formed and substructures developed. The carbides morphology in boundaries coarsened distinctly, and most of the strengthening phase have dissolved or coarsened. However, the tiny V-rich precipitates that formed during service increased the hardness and are responsible for the hardness maintenance in the material [9].

Fig. 1 (a) Scanning electron fractographs of exposed sample from tensile test at room Temperature. (b) Scanning electron fractographs of exposed sample from tensile test at 550 °C. (c) TEM micrograph of thin foil from thin foil from exposed sample. (d) TEM micrograph of thin foil from thin foil from exposed sample (magnified)

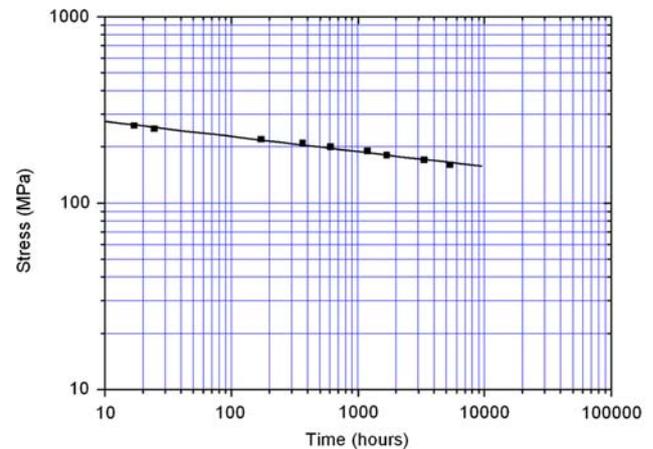
Table 4 list the results of accelerated test at 550 °C. Stress rupture data have been plotted in term of log stress with rupture time in Fig. 2. The curves show that stresses are linear with rupture times; thus, the threshold strength of the main steam pipe at 550 °C was determined by extrapolation method to be:

$$\sigma_{10^5}^{550\text{ }^\circ\text{C}} = 131 \text{ MPa} \quad (1)$$

Fig. 2 Plot of stress with rupture time for service exposed bend at 550 °C

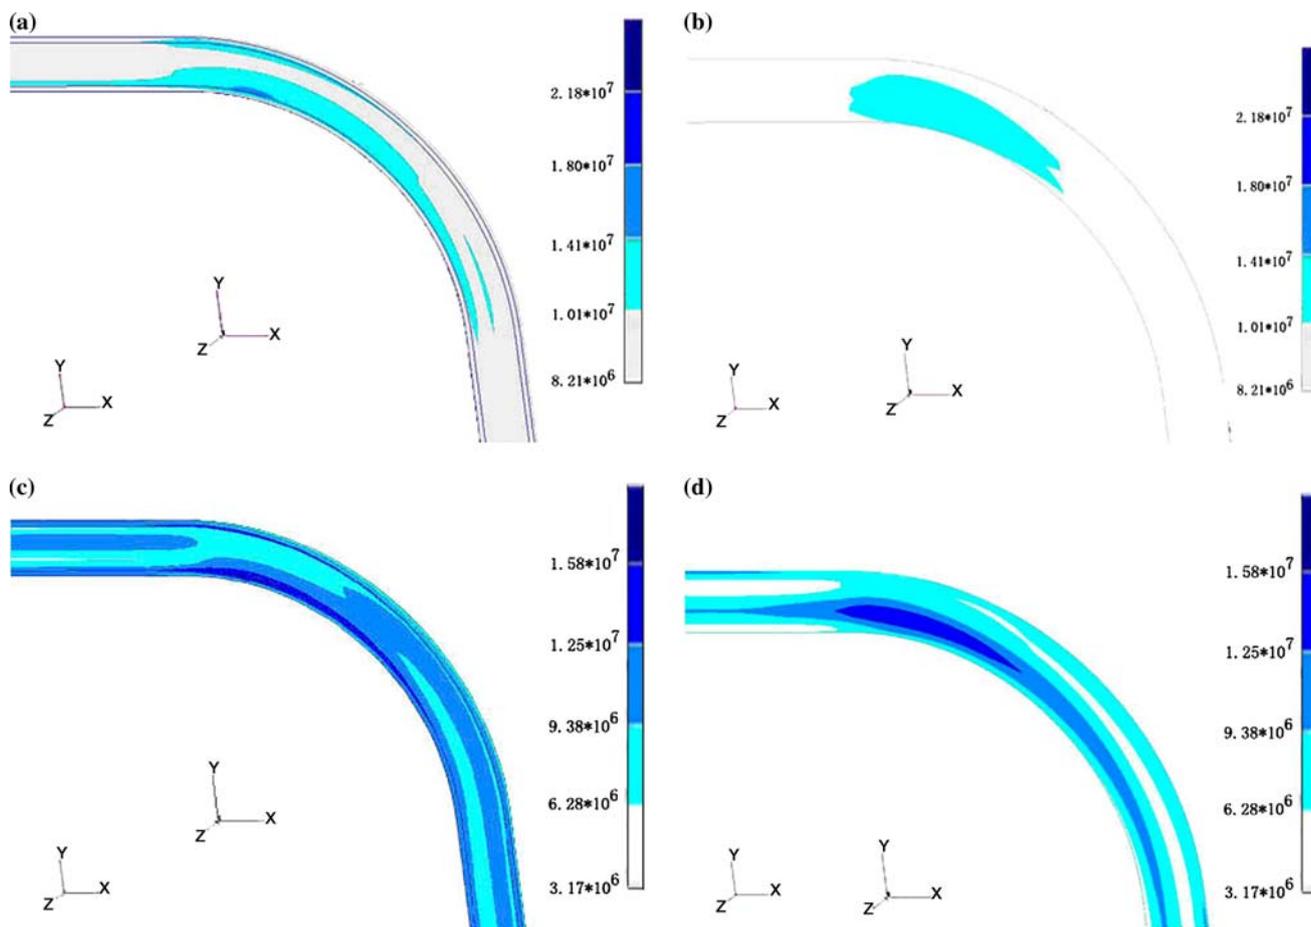
Fig. 3 (a) Distribution of the principal stress (internal of bend). (b) Distribution of the principal stress (external of bend). (c) Distribution of the von Misesl stress (internal of bend). (d) Distribution of the von Misesl stress (external of bend)

Generally, the stress to cause failure may be considered to be either yielding or rupture stress, depending on the criteria used. The corresponding failure theories also consider two types of failure: reaching the ultimate tensile stress for rupture and reaching the Mises yield criterion for yield failure. The calculated results were presented in the form of principal stress (rupture) and Von Mises stress (yielding) simultaneously. The distributions of principal stress are given in Fig. 3(a) and (b). Except for the peak

value induced by loading artificially, the principal stress is 101 MPa. The von Mises stress is given in Fig. 3(c) and (d) and displays the peak stress of about 125 MPa. From above results, under actual operating conditions, the maximum resultant stress loading on the pipe is $\sigma_1 = 125$ MPa. This stress was used to evaluate residual life of the bent sections.

$$[\sigma] = 87.3 \text{ MPa} < \sigma_T = 125 \text{ MPa} \tag{4}$$

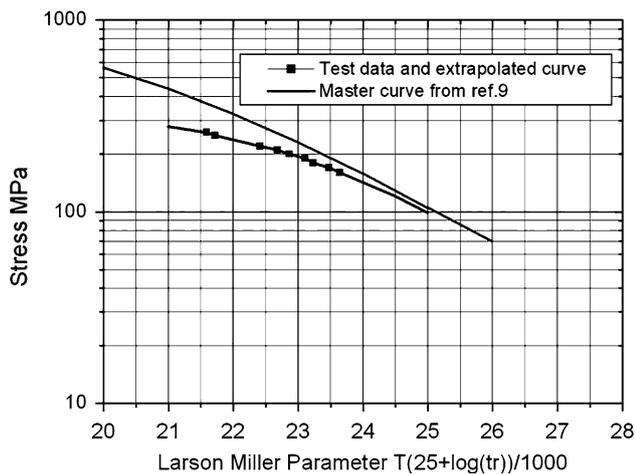
Fig. 4 Plot of stress vs Larson Miller parameter (LMP) for parent metal of bend

The rupture data for the specimens have been plotted in terms of $\log(\text{stress})$ versus Larson-Miller parameter in Fig. 4, where LMP is expressed:

Analysis of rupture data indicates that the properties of the exposed steel are comparable to those of the master curve of virgin pipe [11], suggesting no appreciable creep damage. The test data points of the stress versus LMP plot for the service-exposed material are fairly close to the master curve for virgin material when the stress is less than 200 MPa. The master curve for the virgin material has been extrapolated to a lower stress value that is below the operating hoop stress ($\sigma_h = PD/2t = 72.1$ MPa) of the service-exposed main steam pipe. The remaining life of the service-exposed main steam pipe predicted at 72.1 MPa and at 550 °C is shown in Fig. 4. At the operating hoop stress of 72.1 MPa for the service-exposed pipes, the LMP value as read from the graph is about 25,730. At this value of LMP, one would expect a very long life. As is customary, an inspection life of straight pipe after >100,000 h is recommended. However, considering that the maximum resultant stress on the bent section is $\sigma_1 = 125$ MPa, the LMP value as read from the graph is about 24,398 and the expected residual life is about 44,200 h. The results for the parent metal in the bent section predict a remaining life of about 44,200 h at most highly stressed locations, although failure of the straight sections should not occur in 100,000 h of operation.

This analysis thus suggests that the remaining life at 550 °C is a minimum of 44,200 h for the service, provided

there is no evidence of localized damage in the form of surface cracks or cavitation. Additionally, it is recommended that another health check of the expected service of the exposed bent sections be carried out after 22,000 h of service. During shutdown of the plant, nondestructive tests, namely, dimensional (thickness and diameter) measurement, and in situ metallography may be carried out to assess the condition of the materials for their future serviceability.
