Pitting corrosion on 316L pipes in terephthalic acid (TA) dryer

Y. Gong, J. Cao, X.-H. Meng and Z.-G. Yang*

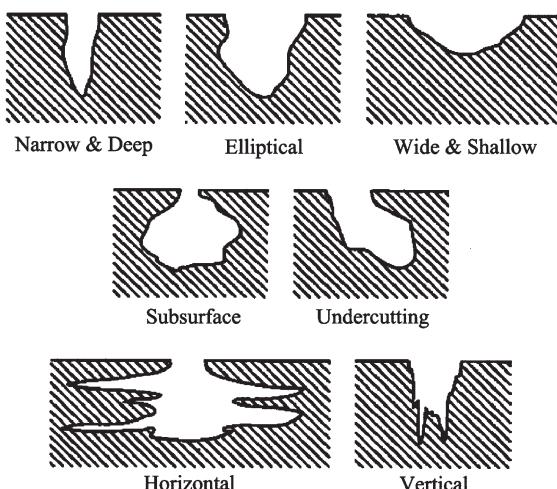
Figure 7. Schematic diagram of theoretical pitting morphologies

with the smooth inner wall, the outer wall was defected by some corrosion pits, whose depth had reached about 0.4 mm. As is well known, there are seven theoretical morphologies of pitting, namely, narrow and deep, elliptical, wide and shallow, subsurface, undercutting, horizontal, and vertical [8]. Schematic diagrams of the seven theoretical morphologies are displayed in Fig. 7. In this paper, it can be seen from Fig. 8 that six out of the seven theoretical pitting morphologies were obtained from the pitted pipes under SEM, which may provide a solid proof for the

theoretical morphologies in practice. Indeed, the various pitting morphologies may also have caused combined side effects on the steam pipes.

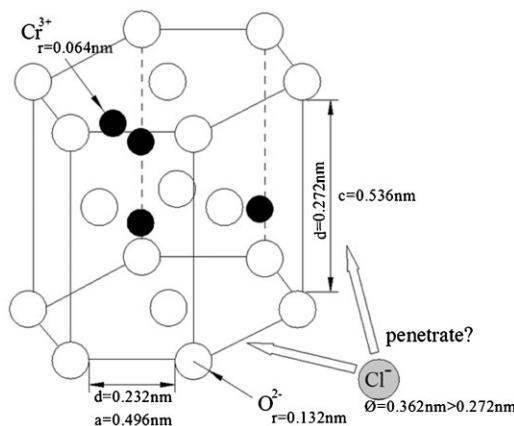
Figure 12. Schematic diagram of Cr_2O_3 crystal

As shown in Fig. 12, the Cr_2O_3 passive film of 316L represents a hexagonal closely packed (hcp) crystalline structure. Compared with the amorphous structure, the crystalline film contains a high density of imperfections such as grain boundaries, dislocations and interstices, which act as the transport paths for small-radius ions through the passive film [32]. In a Cr_2O_3 crystal cell, oxygen ions occupy all the lattice points while the chromium ions are surrounded by six oxygen ions in the octahedral structure. It can also be derived from the literature that the lattice parameters of Cr_2O_3 hcp crystal cell are $a = 0.496$ nm and $c = 0.536$ nm [33]. As the radii of oxygen and chromium ions are 0.132 and 0.064 nm [34], respectively, the actual distances between two lattice points are 0.232 and 0.272 nm, respectively, corresponding to the lattice parameters a and c . Therefore, it is noted that the lattice interstices are not wide enough for a chloride ion with radius of 0.181 nm, i.e. the diameter is 0.362 nm, to penetrate. Thus, it is obvious that the latter theory that ascribes the transport of chloride ions through the Cr_2O_3 passive film for pitting initiation may not be true.

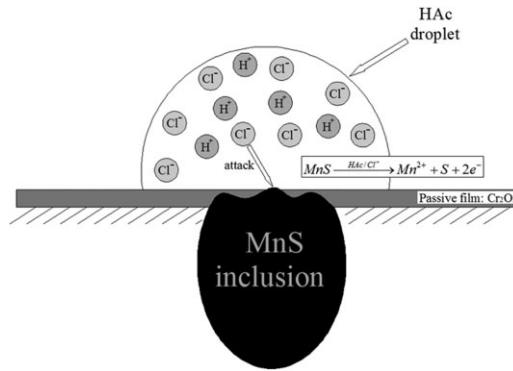
Figure 13. Schematic diagram of the initiation stage of pitting

Briefly speaking, the initiation stage is a process of dissolution of MnS inclusions and formation of corrosion pits.

In this paper, a novel mechanism, different from the two theories mentioned above, is put forward. Actually, it can be learned from Fig. 4 that the MnS inclusions are not completely beneath the Cr_2O_3 film. Hence, emphasis should be laid on the direct attack of chloride ions on the MnS inclusions. Sulfur and chlorine being two neighboring elements in the Periodic Table of Elements, their ions possess similar radii, which are 0.174 and 0.181 nm, respectively [34]. Due to the very small difference between the radii of the two ions, the sulfide ions in thermodynamically unstable MnS inclusions may be substituted by the chloride ions. As a result, soluble $\text{Mn}^{2+}[\text{Cl}^-]_2$ complex compounds are produced. Finally, $\text{M}^{3+}[\text{Cl}^-]_3$ dissolves and leads to the formation of Mn^{2+} ions [equation (3)] and the corrosion pits (Fig. 13).

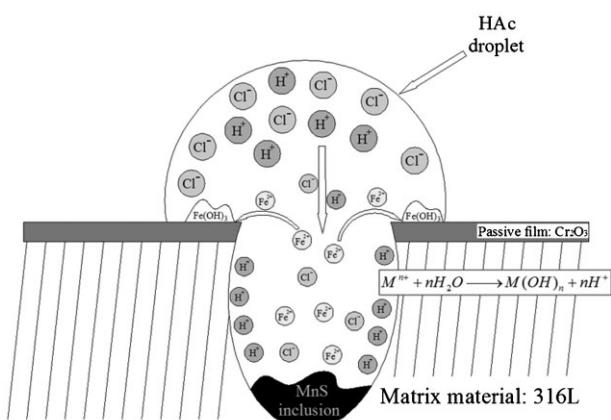
Figure 14. Schematic diagram of the propagation stage of pitting

In fact, the propagation stage is an autocatalytic process assisted by the occluded corrosion cell (OCC). It can be learned from Fig. 14 that, with the outward migration of ferrous ions (II), ferric hydroxide $[\text{Fe}(\text{OH})_3]$ is formed and gets deposited at the pits' mouth [equation (7)], which results in an occluded area in the pits interior [36]. The matrix material exposed to HCl within

the pits serves as the anode due to its activated status, while the Cr₂O₃ passive film outside the pits acts as the cathode. Such a 'small anode-large cathode' OCC will spontaneously cause the pits to grow inwards in the matrix in a deep and narrow form. Thus, the hydrogen ions in the pits' interior continuously attack the matrix to produce metal cations, which hydrolyze to generate hydrogen ions in turn, i.e. the autocatalytic process.
