Hydrogen Embrittlement on High-Speed Stainless Steel Belts Used for Tin Plating Chip Lead Frame

Abstract The 300 series stainless steels generally exhibit good corrosion resistance in common use. However, a premature fracture event caused by hydrogen embrittlement was encountered on 300 series stainless steels which was used as belt hanging chips in a tin plating process for the chip lead frame. The cause of the fracture was carefully studied. A metallurgical microscope and photoelectric direct reading spectrometer were used to examine the metallographic structures and chemical compositions of the matrix material. A scanning electron microscope and energy disperse spectroscopy were also applied to analyze the micro morphologies and micro-area composition of the fracture. Meanwhile, the chemistry and hydrogen content of the process media were inspected by ion chromatography and hydrogen analyzer. In addition, the finite element method was employed to simulate the effect on the belt from the service conditions. The analysis results revealed that the unqualified material selection, the aggressive media, and the inappropriate technological parameters were the main causes of the failur

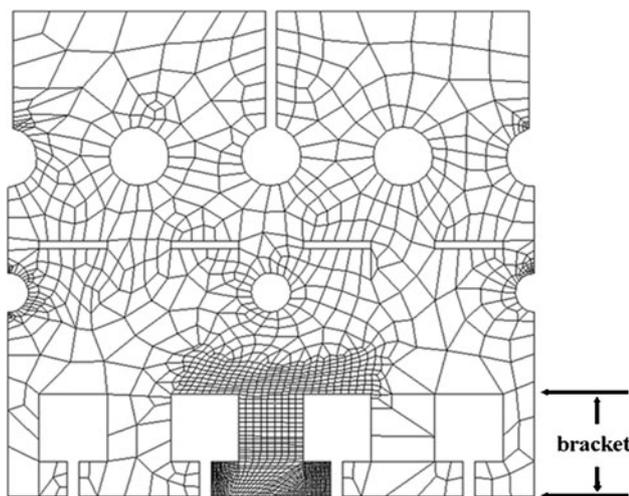
Fig. 9 Meshed FEM model of the stainless steel belt

In order to qualitatively analyze the effect from the high-pressure washing water (20 MPa) imposed on the stainless steel belt, finite element method (FEM) software was employed to simulate the stress distribution on the belt after washing. This is actually a two-dimensional (2-D) transient elastic-dynamic analysis [8–10], and the meshed FEM model with element of PLANE 82 is presented in Fig. 9. The fractured part was further refined for accuracy. Thickness of the belt is 0.5 mm, Poisson ratio and Young’s modulus were set as 0.3 and 2.06×10^5 MPa, respectively. Displacement of the left and right sides (except the bracket)
