# Engineering Failure Analysis

## Failure analysis of one peculiar ‘Yin-Yang’ corrosion morphology on heat exchanger tubes in purified terephthalic acid (PTA) dryer

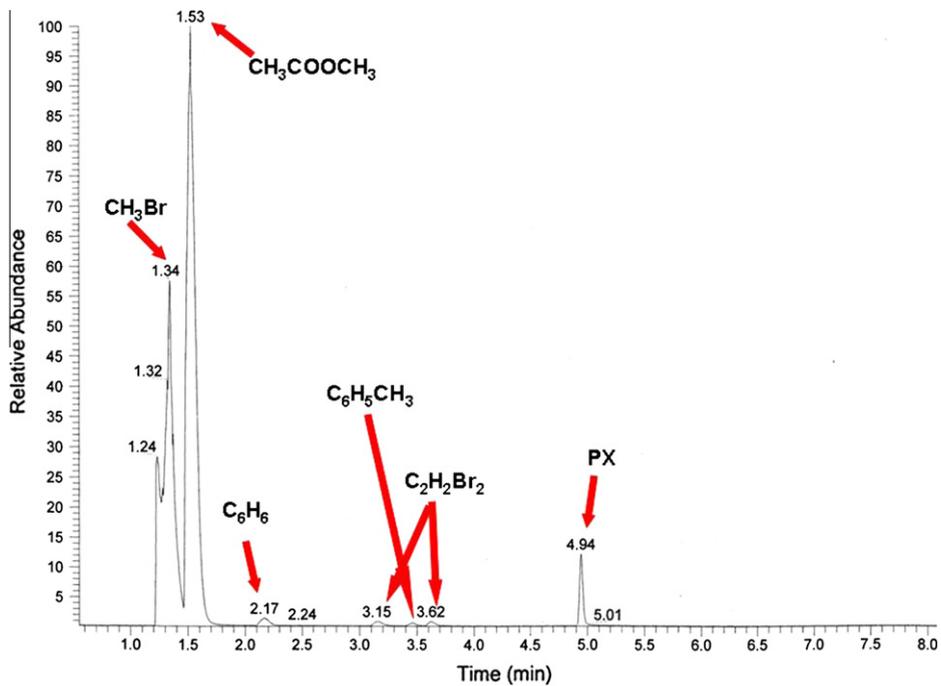
**Fig. 5.** GC-MS results of the exhaust gas from CTA dryer.

Then, in order to find out the corrosive sources of this ‘Yin-Yang’ corrosion, the process media were inspected. Since the catalysts of the hydrogenation reaction were not so aggressive (Eq. (1)), attention was only paid to the process media before the refining unit, i.e. in the oxidation unit, particularly the CTA dryer. Fig. 5 showed the GC–MS result of the exhaust gas that evaporated from the CTA filter cake in the CTA dryer. In it, the peaks at 1.34, 1.53, 2.17 and 3.46 corresponded to  $\text{CH}_3\text{Br}$ ,  $\text{CH}_3\text{COOCH}_3$ , benzene ( $\text{C}_6\text{H}_6$ ) and toluene ( $\text{C}_6\text{H}_5\text{CH}_3$ ) respectively, while the peaks at 3.15 and 3.62 represented  $\text{C}_2\text{H}_2\text{Br}_2$ , and the peak at 6.25 was  $\text{C}_2\text{HBr}_3$ . In fact, all these substances were the by-products generated in the oxidation unit, especially because of the catalysts containing bromine element in the oxidation reaction [13]. However in terms of the refining unit, this GC–MS result positively demonstrated that most of the corrosive factors, i.e. the aggressive bromine element (ions) contained substances, had been ruled out. In other words, the ‘Yin-Yang’ corrosion inside the PTA dryer was not relevant to the process media in the service environment.
